HAWAIIAN VILLAGE
CONDOMINIUM ASSOCIATION

OUTRIGGER

REPLACEMENT RESERVE STUDY

RE: HAWAIIAN VILLAGE CONDOMINIUM ASSOCIATION - OUTRIGGER
Replacement Reserve Report

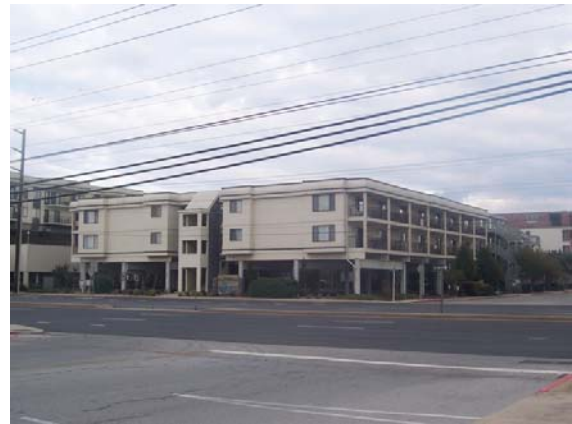
Photo 1 - Side elevation

The subject property appears to be in good overall condition for its age. The general upkeep of the common facilities reflects the conscientiousness of the building manager and staff. This report is based on normal life expectancy of the building components and does not include repair costs related to storm damage. The following comments pertain to the larger, more significant components in the property's inventory and to those items that are unique or deserving of attention because of their condition or the manner in which they have been treated in the analysis.

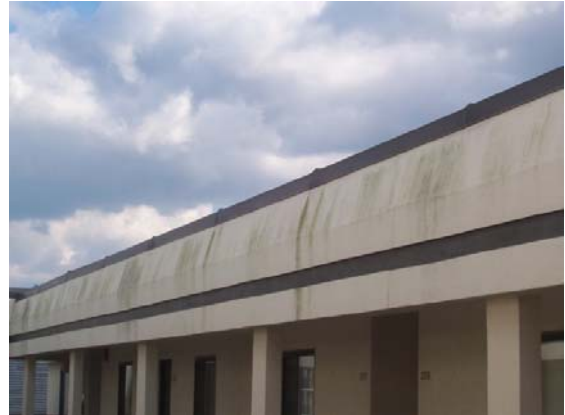
Exterior Finish. The Exterior Wall Insulation and Finish System (EIFS) was visually inspected. The system is showing staining and is in need of recoating. All caulking appears in good condition. EIFS systems have historically experienced problems resulting from faulty installation and inappropriate design details that trap moisture behind the weather barrier. These conditions have caused leaks and structural damage at other locations. Improper detailing can also cause surface cracking. These defects can only be found by close inspection from scaffolding and by removal of small sections of the material to test if moisture is present. We recommend periodic inspection of the building by a professional certified and equipped to conduct this type of inspection.

Photo 2 – EIFS system showing staining

There are different methods of maintaining the EIFS. The preferred method is to apply a silicone based color coat every 10 years. The theory behind installing a color coat is that ultraviolet rays slowly deteriorate the EIFS surface coat over time, which requires that the EIFS be refurbished on a periodic basis.

We recommend that the Association contact EIMA (EIFS industry manufacturers association) to determine inspection requirements and establish an annual inspection program. EIMA may be reached at the following:

For the Reserve Study we have included an allowance for re-coating and caulking of the EIFS surface every 10 years. We included the joint caulking at the same time as re-coating to take advantage of the scaffolding in place.

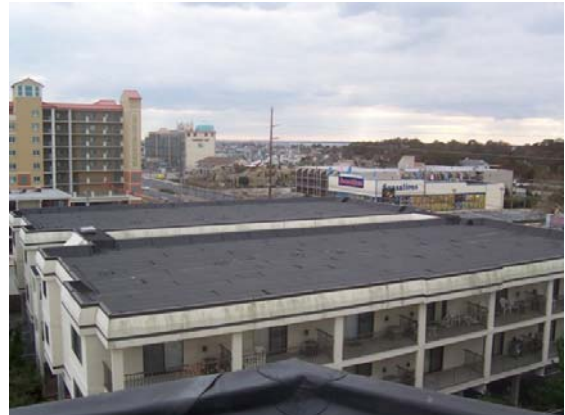
Roofing. The roof is covered with a fully adhered single membrane. The roofing system was replaced in 2004 and is in very good condition.

Photo 3 - Single ply roofing system - adhered

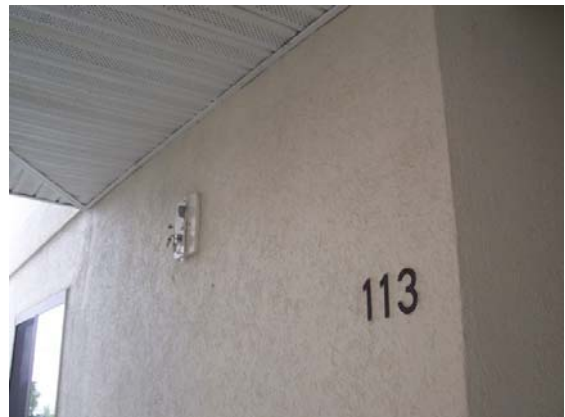
Sprinkler (fire suppression) System. The building is equipped with a fire suppression system. The system is tagged with an appropriate 3rd party inspection sticker and our cursory observations of the primary components did not reveal any defects. However, evaluation and testing of this system was beyond the scope of the inspection. Consultation with the firm which has been servicing the equipment is recommended.

Photo 4 - Fire alarm and missing exit sign
