A Home Inspector's Journal: Crawl Space Framing Alterations

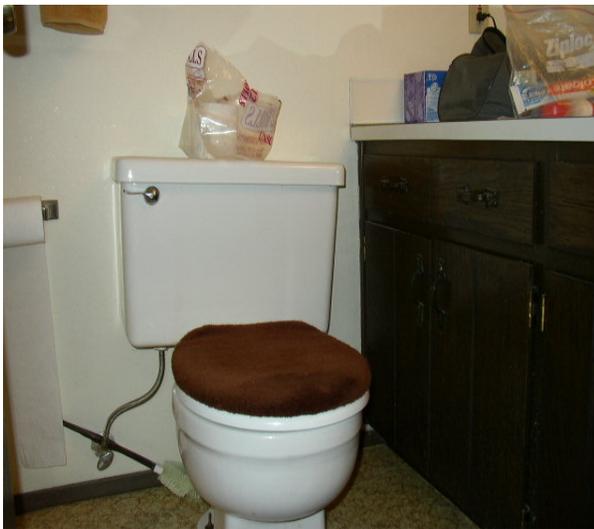
In the picture to the left, one can see clearly that the toilet is leaning noticeably to the right. The counter top is also sloped downward toward the toilet. While not visible in the picture, the countertop is actually separating from the wall at the back splash. There is a considerable amount of flex and bounciness in the floor and the toilet even shakes when someone walks into the bathroom. If the condition is not identified and corrected further damages may occur. At a minimum, there is a risk the toilet could lose its seal and begin to leak, causing decay to the flooring beneath. It is also possible the sink plumbing could come loose and start to leak.

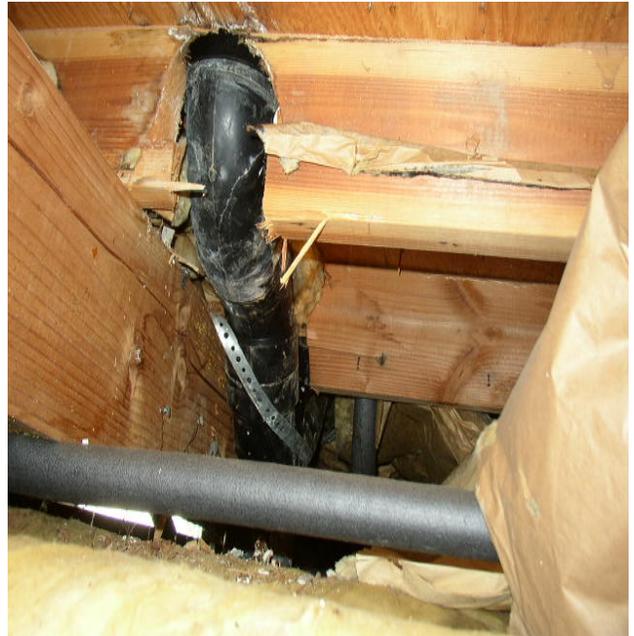
In the picture on the right, taken from the crawl space underneath the bathroom, the cause becomes clear: Because of the layout of the substructure framing, there was no room to accommodate the drain pipes from the toilet when the structure was built. (The toilet drain line is the large black pipe at the top of the picture which you can see going upwards through the plywood sub floor. The base of the toilet is immediately above it). The resolution to the dilemma, which appears to go back to the time of original construction, was to cut the floor joists completely through so that there was room for the pipes. As the over-cut floor joists simply could not provide adequate support, the cumulative weight load from above caused them to sag downward over time resulting in a weak, springy floor, a leaning, unstable toilet and a deflected, separating countertop.
