## Building Inspection & Analysis

## PROPERTY CONDITION REPORT

**Client(s):** Mr. & Mrs. Commercial Investor  
**Property:** 3251 Beacon Blvd,  
West Sacramento, CA 95691  
**Realtor:** Mr. Commercial Realtor  
**Date:** Wednesday, June 23, 2010  
**Inspector:** Rick DeBoard - Certification #1051  
**Report #:** PCA6634

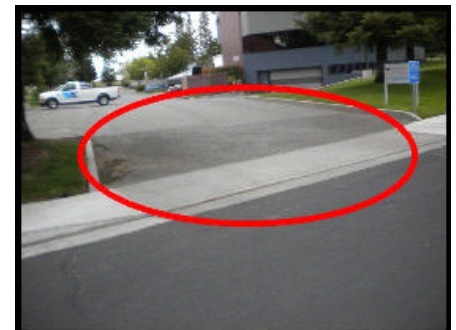
All parking surfaces on the lot are paved with asphalt. A seal coat is recommended within the next year to seal cracks and extend the life of the asphalt surface.

The erosion to the parking surface appears to be past the point of repairing at the eastern driveway off Beacon Blvd. Therefore we recommend pulverizing the asphalt at this driveway, using the resulting granulated product as base rock, and installing new asphalt over the top.

Space marking of the parking stalls is relatively poor. We recommend a fresh coat of paint be applied to the stall markings after seal coating. Cost-to-Cure = \$28,000.

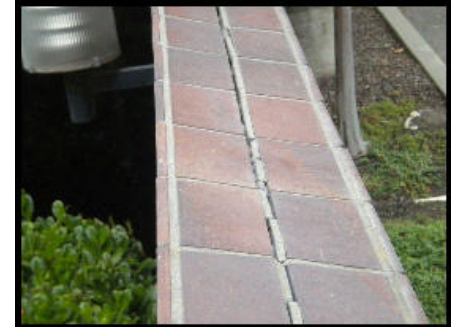
The masonry privacy wall at the south side of the patio area has grout missing at the top, which will allow moisture to soak into the framing. This is a minor cost item.

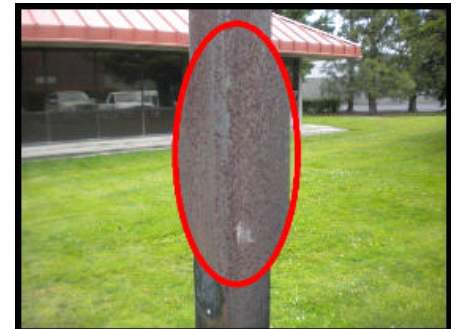
The parking lot light poles are in need of a fresh coat of paint. Cost-to-Cure = \$1,800.

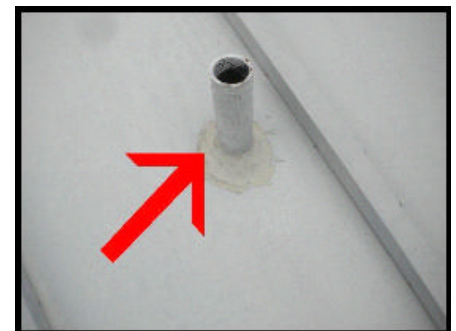
The lack of proper flashings are possibly the cause of the former leakage indicated by the stains on the wall below the ceiling of the ATRIUM.

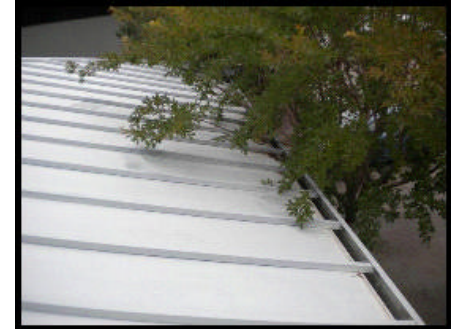
Trees or shrubbery are over hanging the roof surface, we recommend that overhanging trees be trimmed back where they are likely to come into contact with roof or eaves. This item should be added to your list of regularly scheduled maintenance procedures, no cost estimates are given.

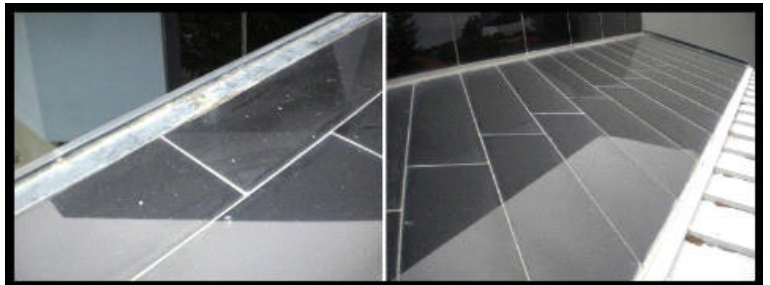
This is a glass panel roof. These roofs require annual maintenance to seal the glass to the metal framework. No leaks noted at this time. Visible sealant was noted at many panels around the perimeter, this may be an indication of former leakage. This item should be added to your list of regularly scheduled maintenance procedures, no cost estimates are given.

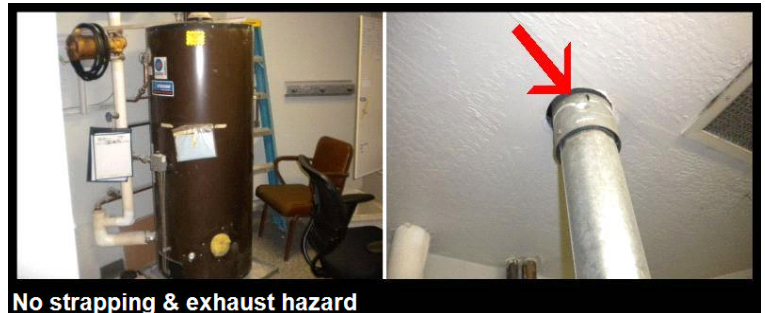
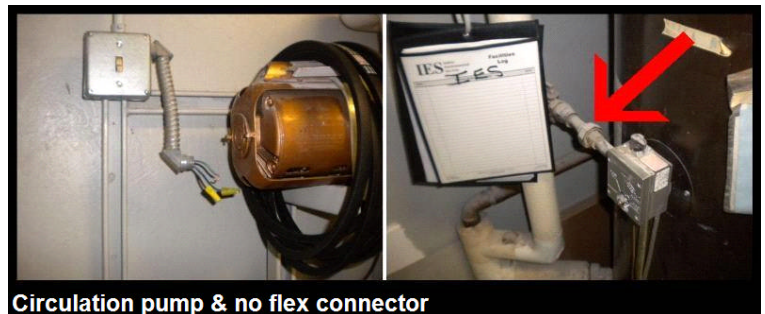
Circulation pump is not functional and it has been disconnected. This is a minor cost item.

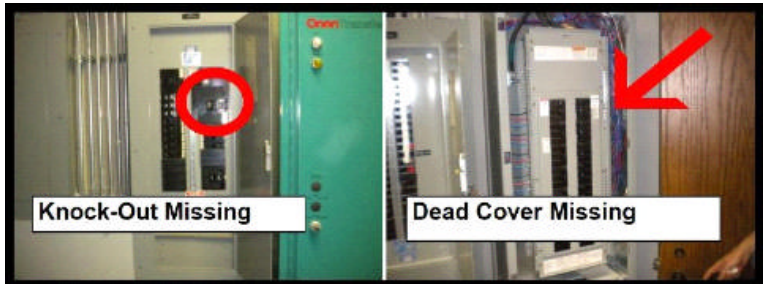
Unused openings in approximately two panels are missing covers. (These covers can be either plastic or

metal and are called knock-outs, they are available at most hardware stores for less than a dollar. They simply clip into place without the use of any tools). However, they are important because without them one could stick their fingers into the panel and come into direct contact with high voltage. The dead cover is missing at one of the panels, this allows easy access to high voltage. These are minor cost items.

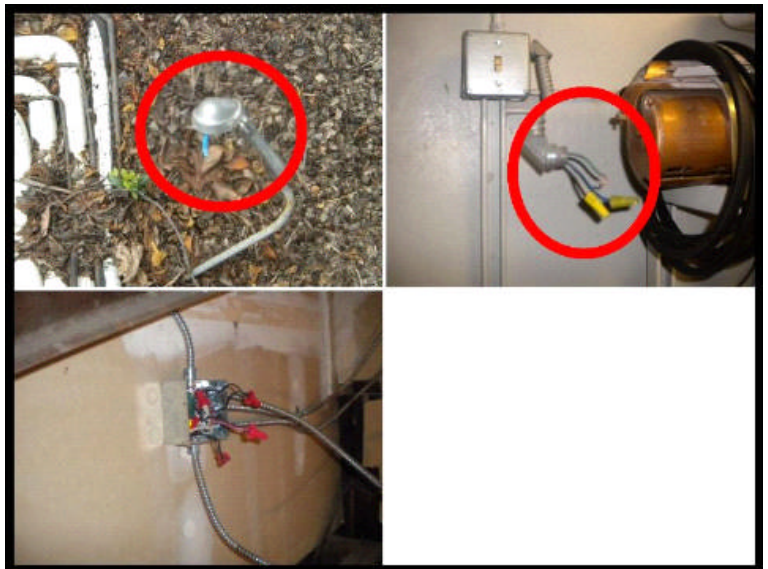
Although covers are inexpensive to purchase and install, they are very important because they contain any sparks within the box in the event that wire connections become loose.

These are minor cost items.

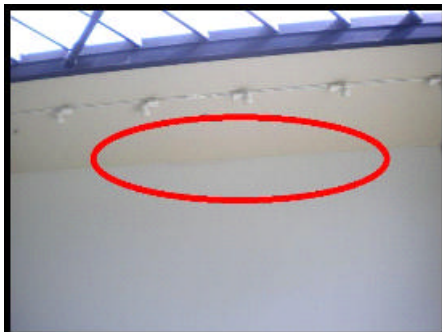
Moisture stains were noted at top of the south wall in the main lobby, directly under the glass atrium roof. These appear to be from a past leak in the roof (owner states that it was repaired).

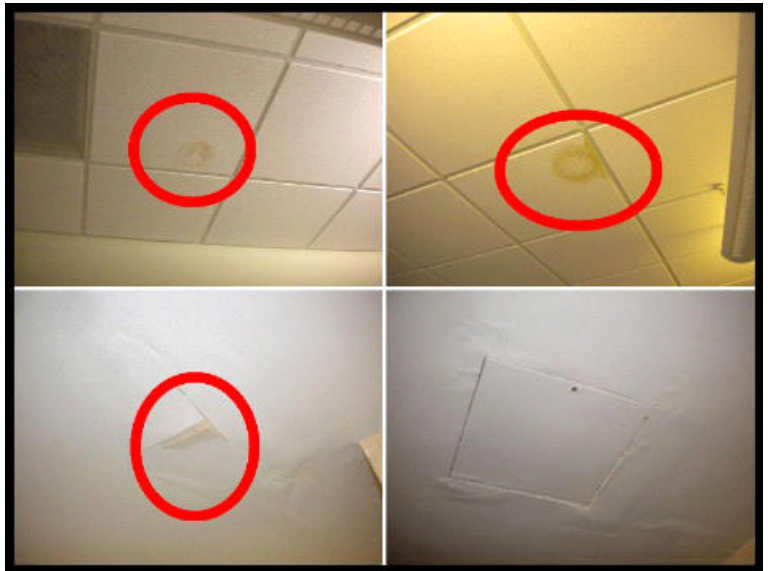
The majority of the ceilings are sheetrock and dropped down T-Bar type panels. Ceilings are in serviceable condition. A few small moisture stains were noted at the ceiling tiles of each floor, and also some at the sheetrock ceiling of the men's and women's restrooms of the 1st floor.

We believe the stains at the ceiling panels of the building are the result of condensation build-up at the A/C plenums (which are directly above the stains). Plenum condensation is very common, and there is little that can be done to eliminate this condition. We suggest having ceiling panels on hand for replacement when necessary. This is a minor cost item.

The stains at the restrooms APPEAR to be the result of past, rather than current, plumbing leakage from the restrooms above. However it is not possible to be absolutely certain.

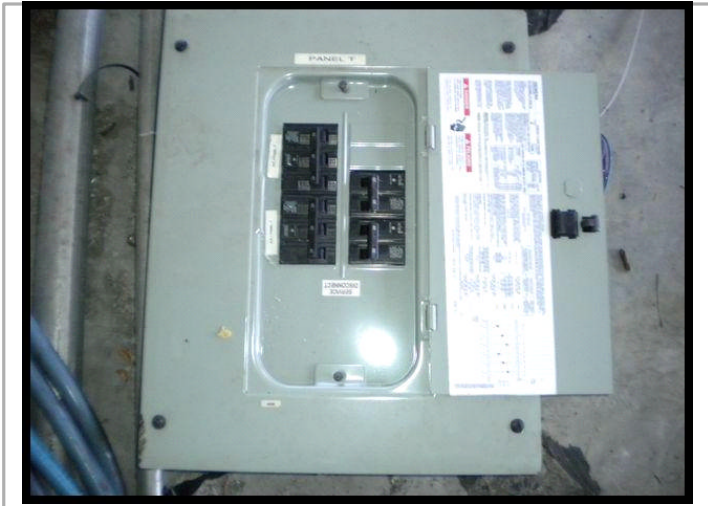
**Photo #29** →

Panel at the abandoned and gutted server room of the 2nd floor. This panel has been abandoned (all wires removed from breakers), however, it still has hot wires connected to the busbars.

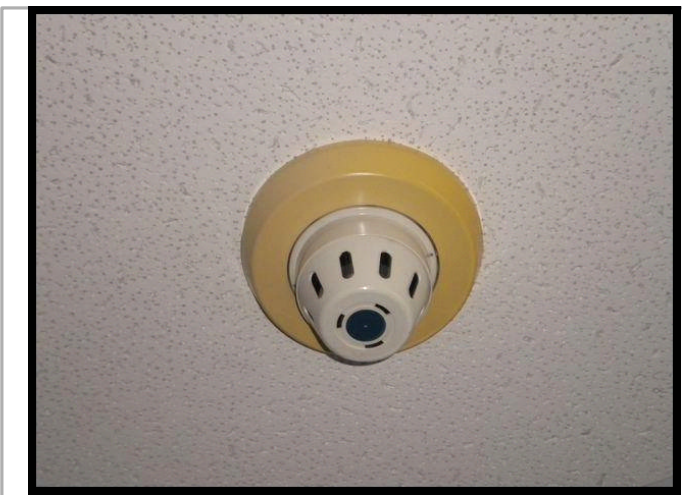
**← Photo #36**

One of the abandoned Ansul Halon 1031 smoke/heat detectors at the abandoned 2nd floor server room. This one is located at the ceiling. All systems relating to this Ansul System have been abandoned.
