PROPERTY CONDITION REPORT

Client(s): Sample Apartment Complex
Property: 1402 Washington St,
Calistoga, CA 94515
Realtor: Not Applicable
Date: December 12, 2015
Inspector: Rick DeBoard - Certification #1051
Report #: PCA7306

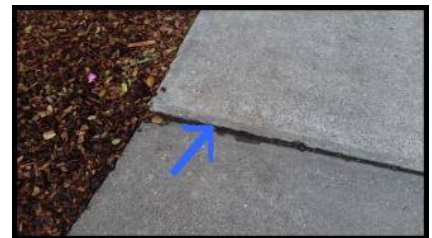
Tripping hazards were noted at the private walkway to the north of Bldg A, (where there is an abrupt change of 1" or more in the height of the surface). We recommend grinding the concrete to eliminate the tripping hazard. This is a minor cost item.

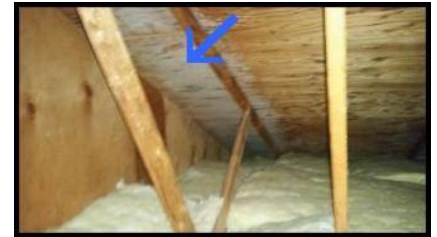
There is evidence of mold/mildew on the underside of plywood sheathing above each of the upper apartments, as seen from the attics. We are unable to determine the cause of this condition as there appears to be adequate ventilation in all units. We recommend further evaluation by a properly qualified roofing contractor.

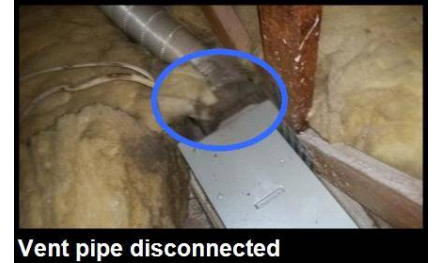
One or more restroom/bathroom exhaust fans are NOT vented to exterior, but are terminated or disconnected in the attic space. This condition can create excessive moisture in the attic. This condition was noted at the bathroom fan of apt 6. This is a minor cost item.

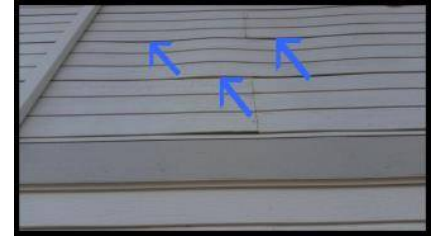
NOTE: Fiberboard siding is known to deteriorate faster than other materials when moisture gains access to unpainted areas. We recommend that joints and ends of siding & trim components be adequately painted and caulked at all times.

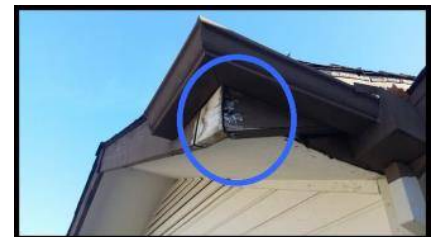
The fascia board(s) is/are damaged/deteriorated at the west side of apt 8 and the east side of apt 9. These are minor cost items.

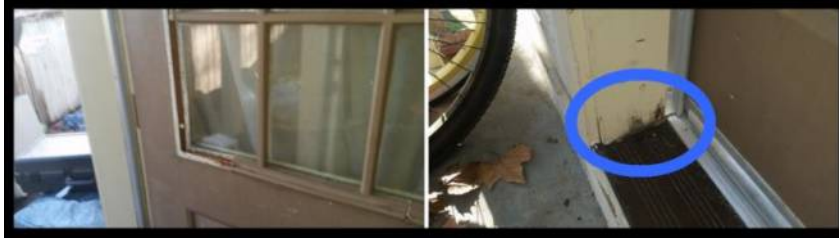
3. Two door jams are moisture damaged at apt 8.

Cost-to-Cure to repair or replace = \$2750.

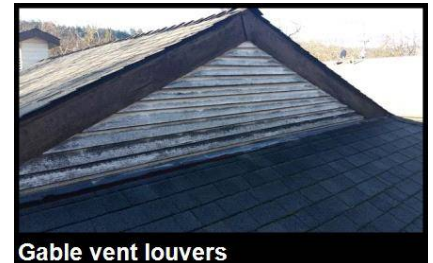
1. Paint/stain is near the end of its useful life at all gable attic vent louvers and some fascia boards.
2. Caulking at siding butt joints is missing or in poor condition at many areas.

Gable vent louvers

Cost-to-Cure =\$3,000.

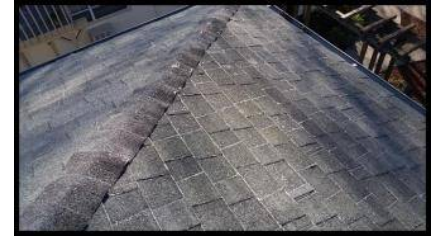
The granular surface is beginning to show signs of deterioration from the ultraviolet rays of the sun, this is a normal sign of aging and indicates a limited life expectancy.

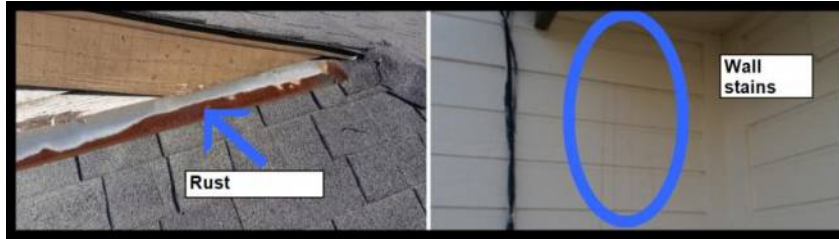
Active leakage is noted through the wall-to-roof flashing at the southeast corner of the laundry roof (as evidenced by moisture stains running down the wall under the eave overhang of the laundry room.) We recommend that a licensed roof contractor examine and take corrective actions.

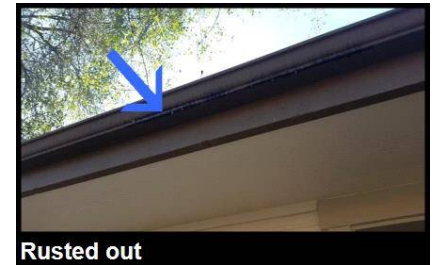
1. Gutters were noted to be rusted through and leaking at the north end of bldg A.
2. Accelerated rusting noted at the interior of all gutters. This is typical for older gutters but indicates a limited life expectancy.

We recommend all gutters be replaced when the buildings are re-roofed.
Cost-to-Cure = \$6,000.

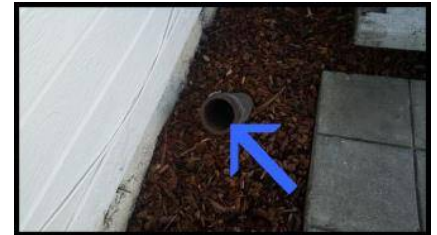
An open waste line was noted at the cleanout to the south of bldg A. This is a minor cost item.

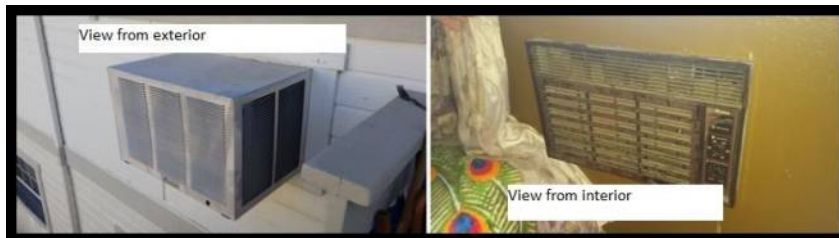
Twenty five of the heat pumps are past their typical expected life. You should anticipate the need to replace these components within the next 5 years.

Projected Expense = \$25,000.

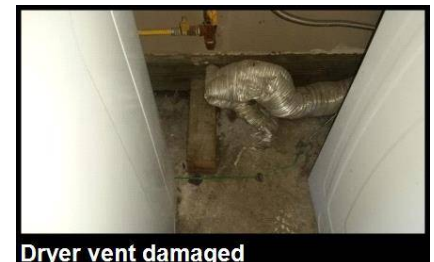
2. Laundry dryer vent is damaged.

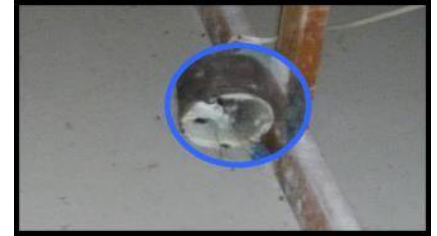
Junction or ceiling boxes were noted to be without covers at the attic of apt 6. Although covers are inexpensive to purchase and install, they are very important because they contain any sparks within the box in the event that wire connections become loose. This is a minor cost item.

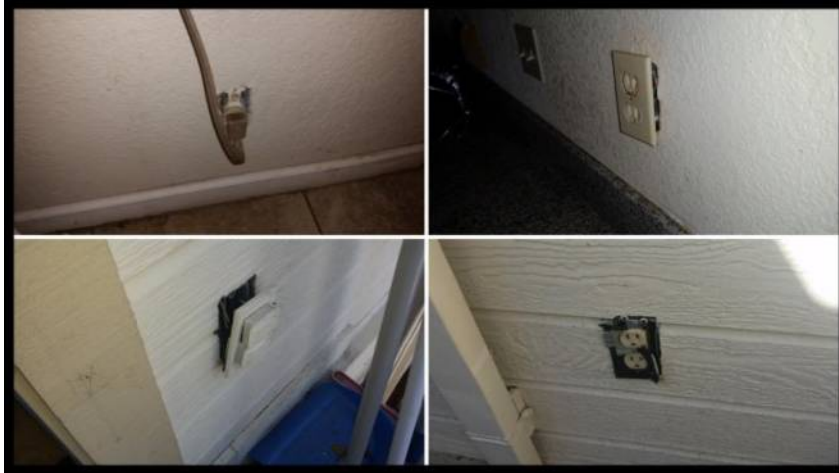
1. GFCI, (Ground Fault Circuit Interrupters) are not operational at the bathrooms in apts 4 & 7 and at the kitchen in apt 5.
2. Missing or damaged face plates were noted at some outlets or switches at apts 1 & 7. This is an inexpensive repair, however it is very important because the lack of a face plate can allow sparks to escape the outlet/switch box.
3. Loose/damaged outlets or switches were noted at apts 1, 5 and at the exterior of apts 4 & 6.
4. One or more outlets are not functioning at the bathroom of apt 6.
5. There are outlets which do not appear to be GFCI protected, (Ground Fault Circuit Interrupters) at apt 6 kitchen.
6. One or more switches are not functioning at the bathrooms of apt 1.

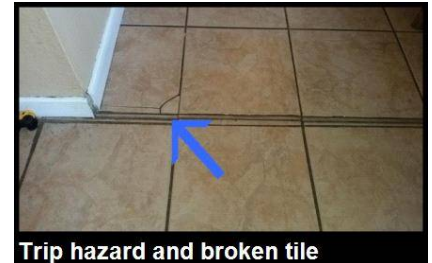
There is a 1" height difference when going from living room to kitchen in apt 6, this is a tripping hazard! We recommend a sloped transition threshold be installed. This is a minor cost item.

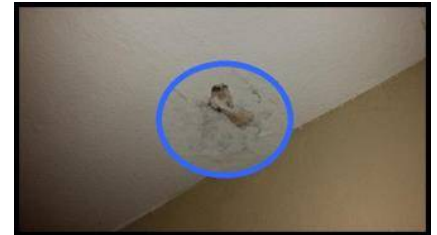
Organic growth type substance was noted at the ceiling of the bathroom in apt 2, see the recommendations in the section above.

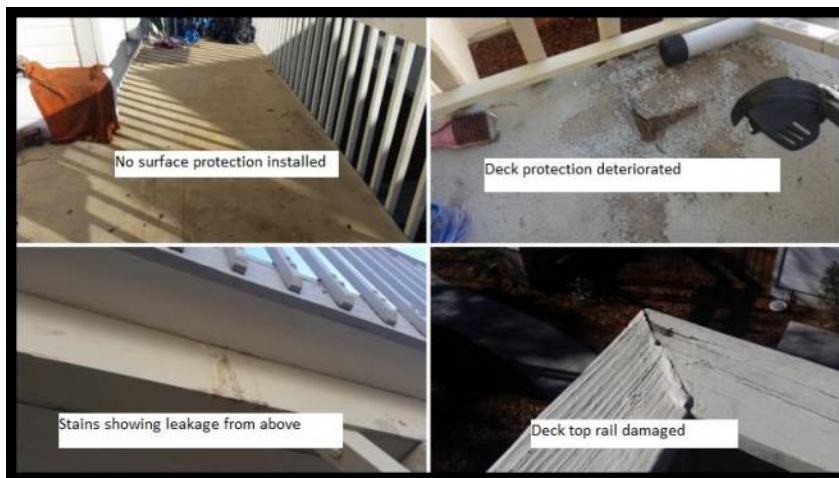
1. The plywood deck surface is unprotected against moisture intrusion at the east side of building A.
2. The surface protection is deteriorated at the west deck of apt 6, the west deck of apt 7, the west deck of apt 8/9, the east deck of apt 9, and at the west deck of apt 10.
3. The rim joists are deteriorated at the west deck of apt 7 and at the west deck of apt 8/9.
4. The base of the deck posts are deteriorated at west deck of apt 8/9 and at the east deck of apt 10.
5. The top rails are slightly deteriorated at west deck railing of apt 6, the west deck railing of apt 8 and the east deck railing of apt 9.
6. Many various balustrades are slightly deteriorated at almost all decks.

Cost-to-Cure = \$5,800.
