## PROPERTY CONDITION REPORT

**Client(s):** Mr. George Sample  
**Property:** 8492 CA-116,  
Cotati, CA 94931  
**Realtor:** Not Applicable  
**Date:** Tuesday, November 18, 2014  
**Inspector:** Rick DeBoard - Certification #1051  
**Report #:** PCA7185

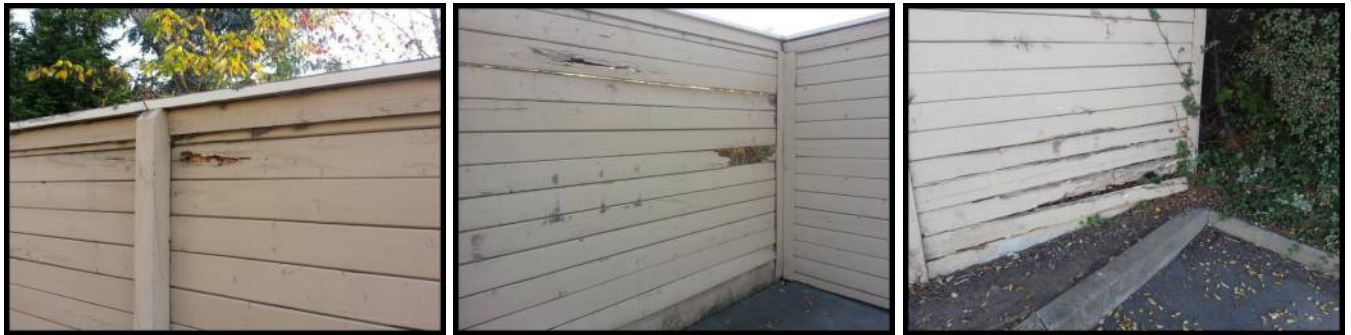
Fair condition, Fencing on the property is constructed of wood type components. Many deteriorated fence boards/rails noted. You should anticipate the need to replace this/these components within the next 5 years.  
Projected Expense = \$15,000.

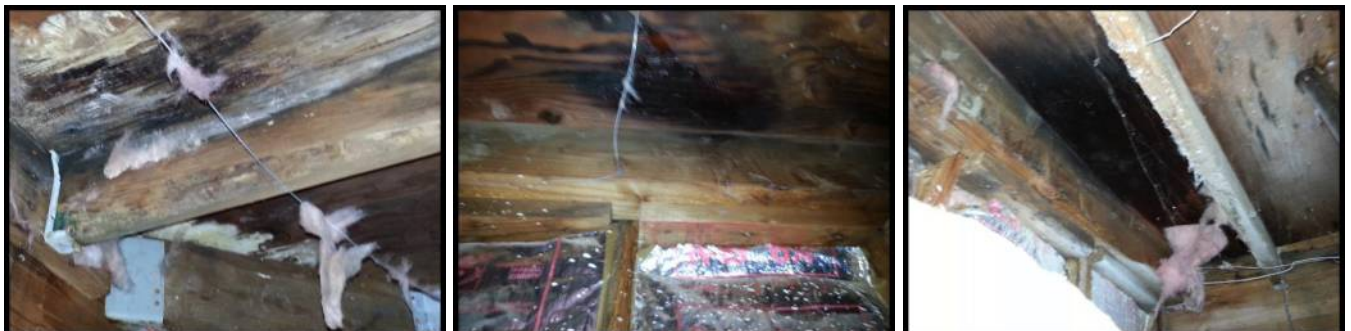
The roof sheathing at the high eave is deteriorated at the south exterior wall of suite E, F & G, from an apparent current roof leak.

Cost-to-Cure is Included in roofing estimate. See below and in roofing report appendix.

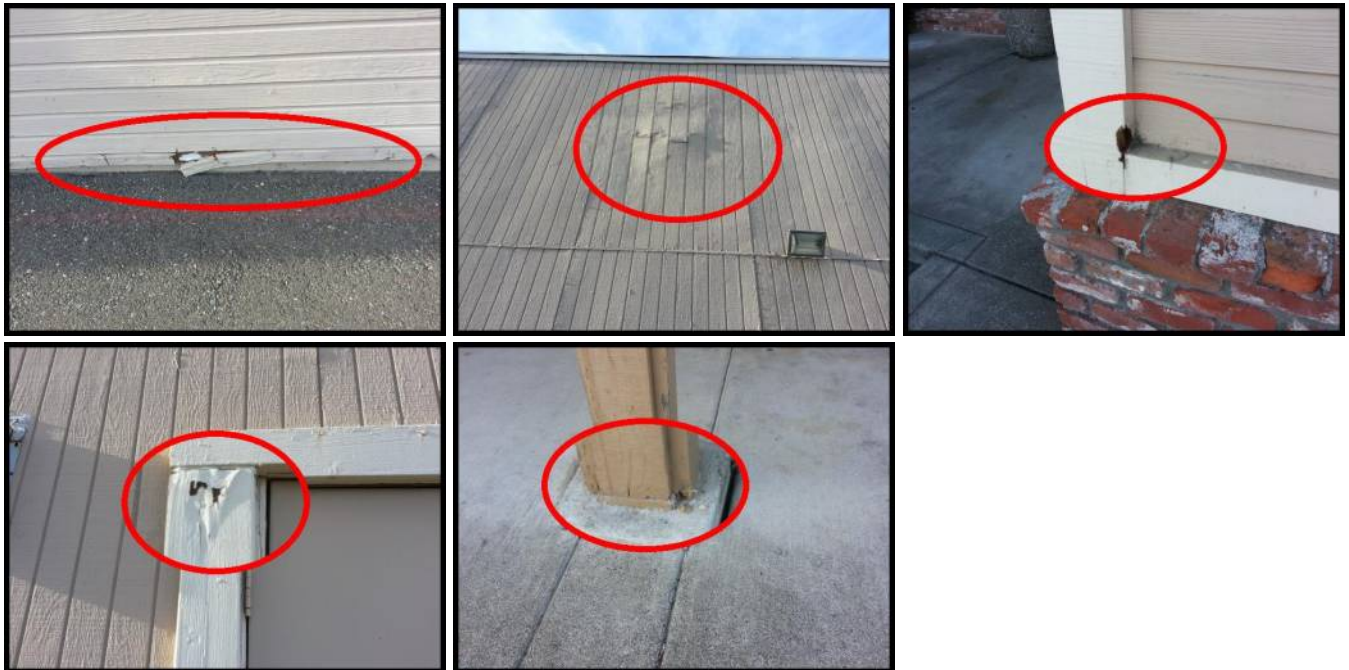
1. Damage/deterioration noted to most of the wall panels to the southeast side of suites A, B, D & E, due to a lack of paint maintenance.
2. Horizontal siding splices have been made without the use of Z-bar flashing at the west wall of suite K. Z-bar flashing is used to eliminate the potential for moisture entry into the wall cavities at horizontal joints. We recommend installing the proper flashings.
3. Damage/deterioration noted to siding and trim components at the base of the five large columns to the west and north of the building (the large columns with bricks at the base).
4. Damage/deterioration noted at the walk door trim at the southeast of suite D/E.
5. Damage/deterioration noted at the trim at nine of the smaller overhand support columns along the east and north sides of the building.

Cost-to-Cure = \$19,000.

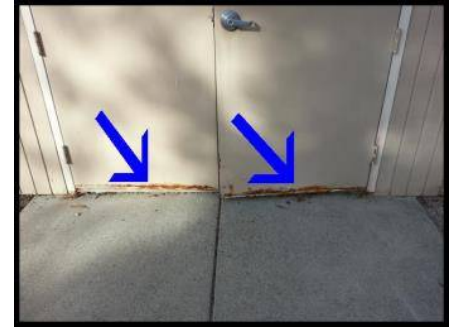
The southeast entrance door of suite D/E, the south entrance door of suite F, and the storage entrance door to the west of suite L.  
Projected Expense = \$3,500.

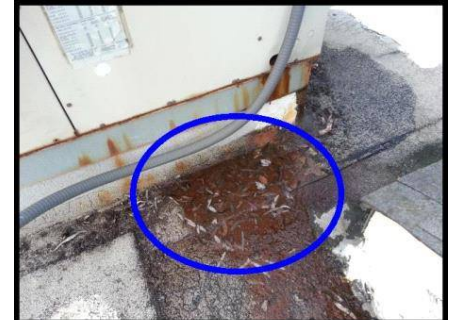
Condensate drain stains on roofing surface

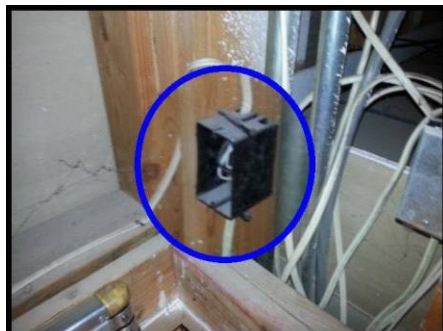
No junction box cover

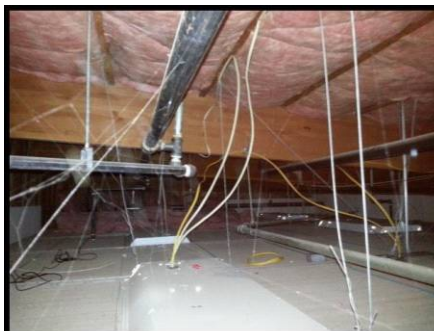
Loose wiring

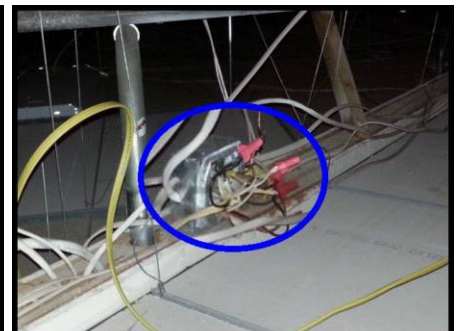
No junction box cover

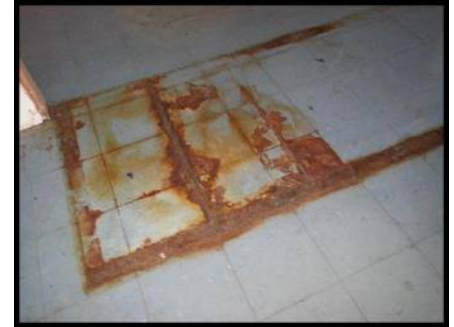
Floor coverings are moisture damaged at suite F in need of replacement.  
Projected Expense = \$10,000.

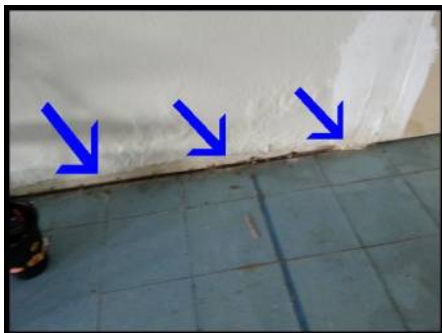
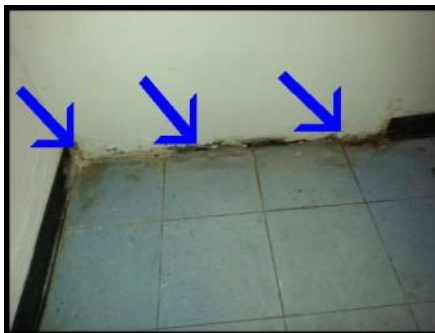
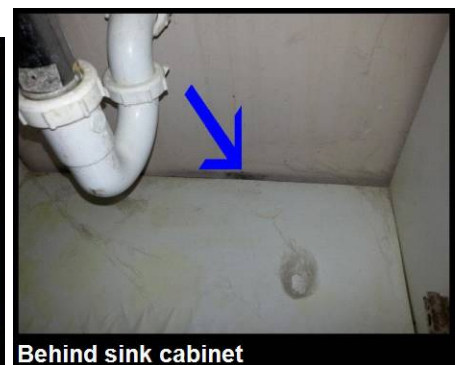
Organic growth type substance was noted at the walls of suite G in both restrooms, see the recommendations regarding a MOLD inspection in the EXECUTIVE SUMMARY section of this report.

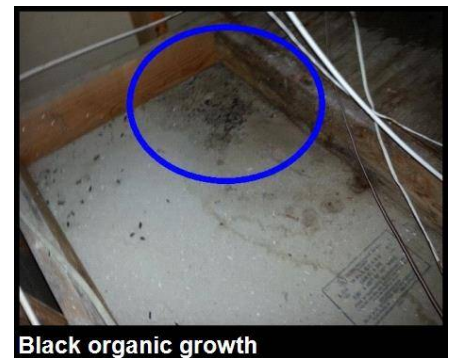
Organic growth type substance was noted at the sheetrock on the attic side above the restroom in suite F, apparently from a former water heater leak. See the recommendations in the SUMMARY section of this report.

Black organic growth

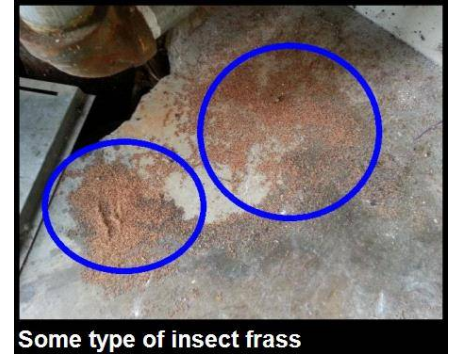
Evidence of wood destroying pests was noted at the floor of the electrical room. We recommend a pest inspection be performed by a properly licensed pest control operator.

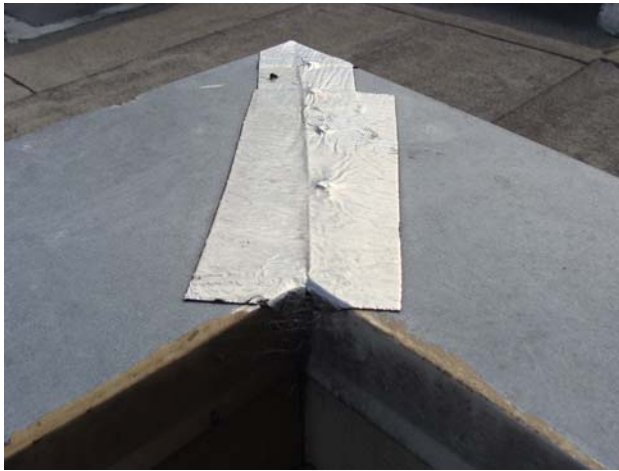
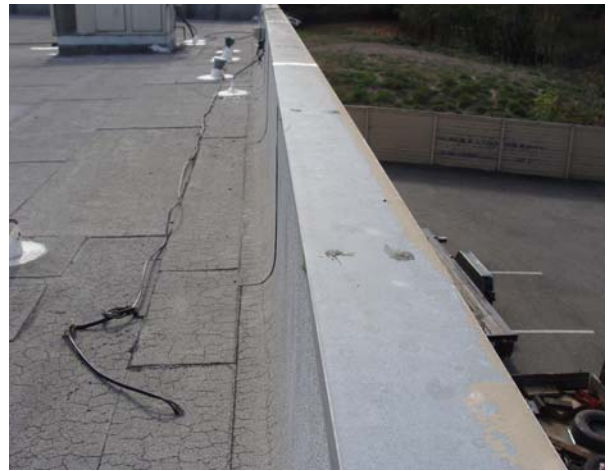
- A. Wall Cap Metal:** It was noted that the wall cap metal flashing was generally in good condition and fastened correctly. It was noted that the seams in the cap metal have been sealed with compression tape. Many of the fasteners are exposed and the sealant has failed.

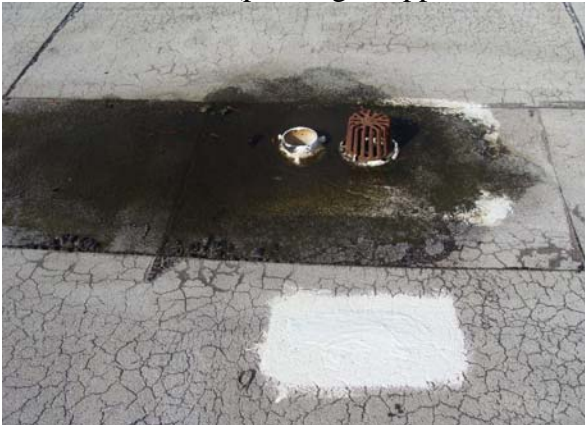
- B. Compression style sump drains and overflow drains:** The main low slope roof area drains to six internal drains. Almost no ponding is evident on the roof, though a small amount was noted at three of the drain sites. (ponding at upper area of roof noted below)

**Compression drain and overflow**

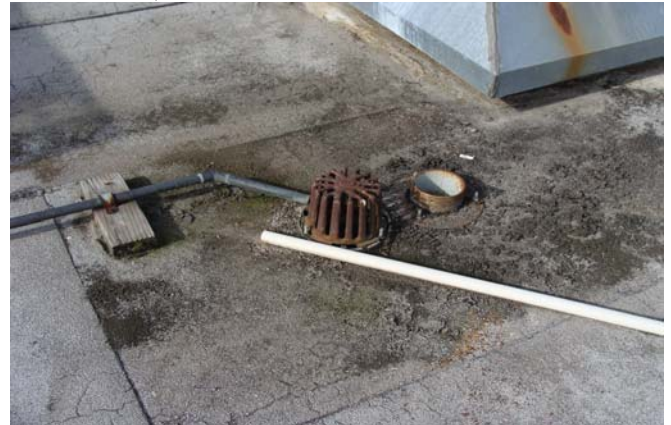
**Condensation lines from A/C units at drain**

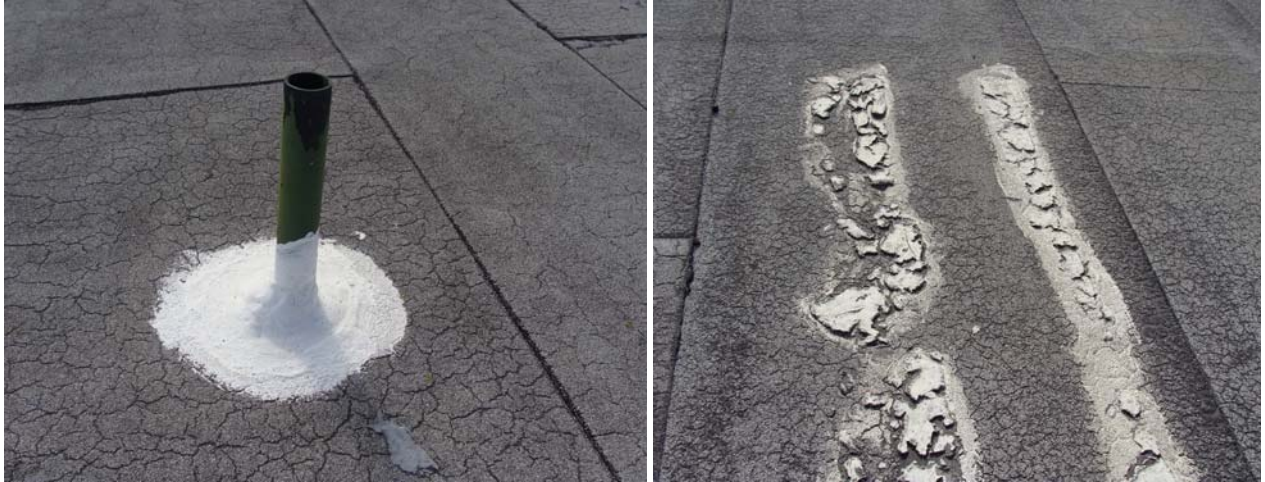
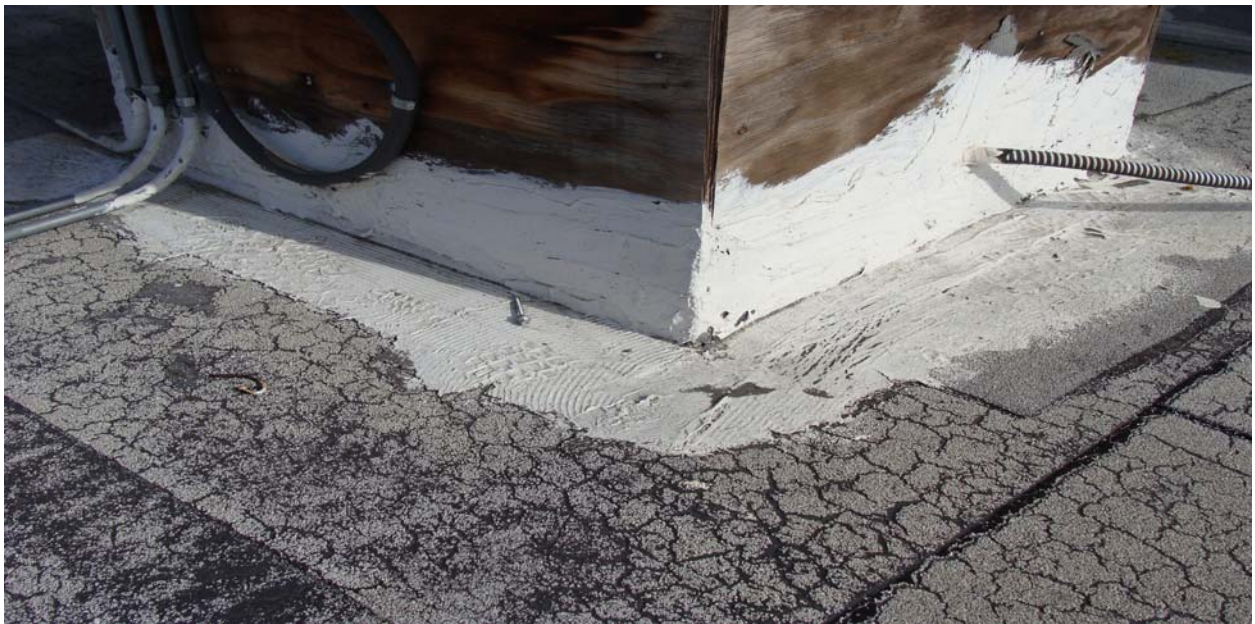
- C. Details and Repairs to the Low Slope system:** Numerous repairs to the roof system were noted. Every roof penetration has been coated with an elastomeric coating, and several areas have been repaired using asphalt mastic. One area has been torn out and replaced with a new section of membrane.

Poorly installed mechanical unit with elastomeric coating at the curb. Numerous details of this quality were noted.

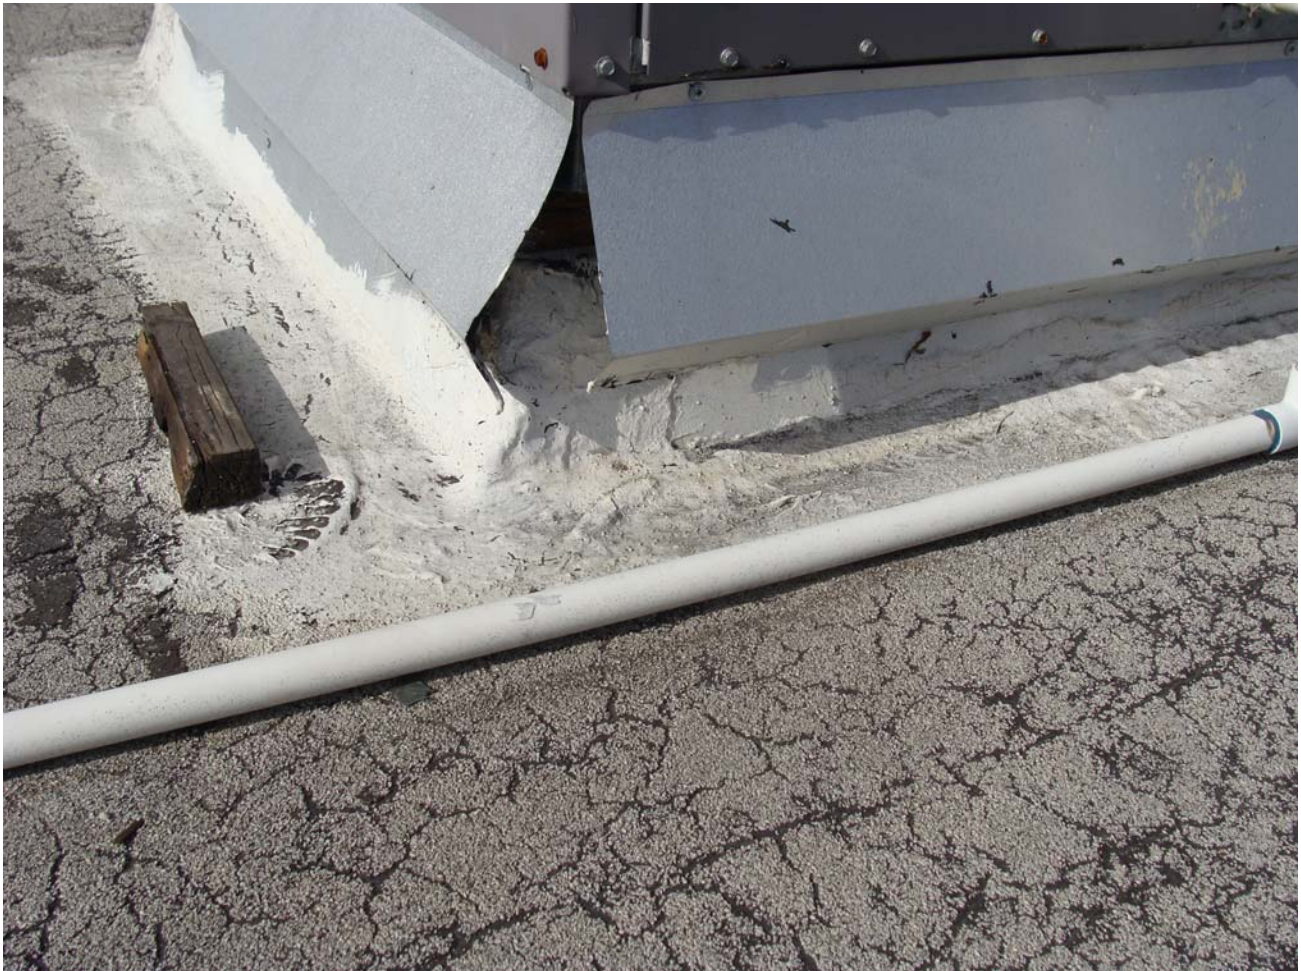
This photo shows an improperly flashed mechanical unit as well as the cracking or aligating of the mineral surfaced cap sheet.

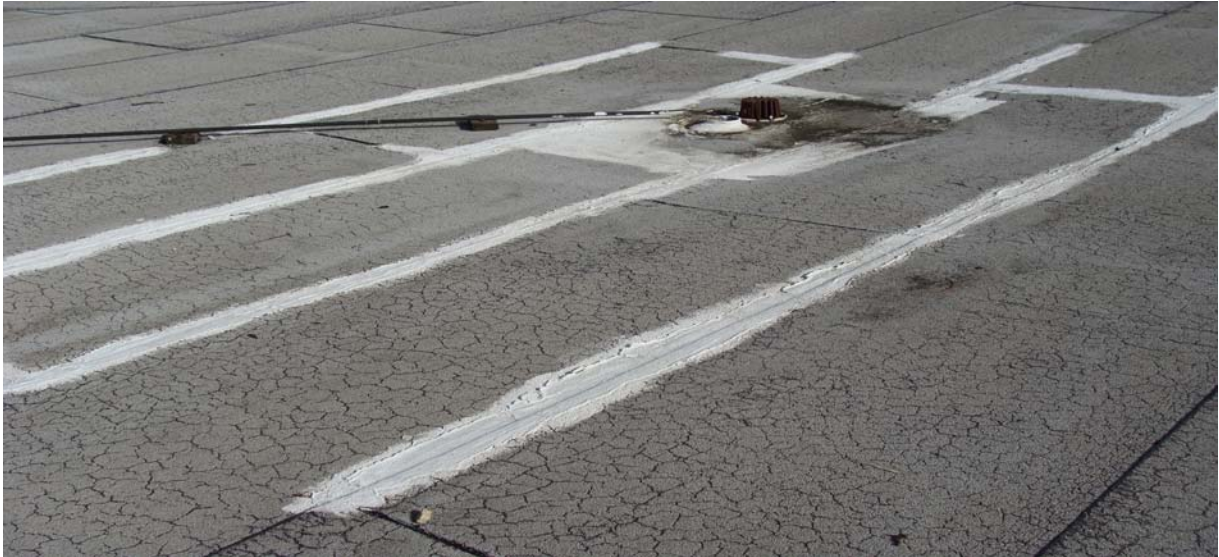
More repairs using elastomeric paint or coating at the seams in the cap sheet.

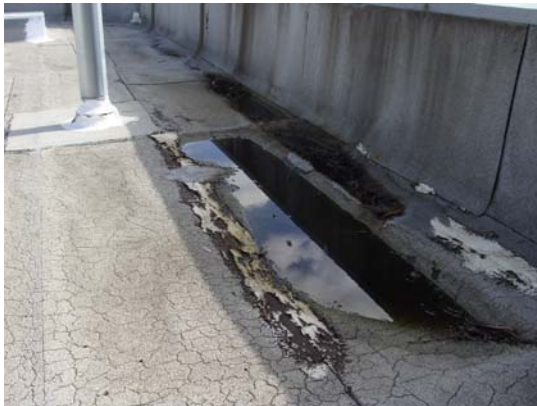
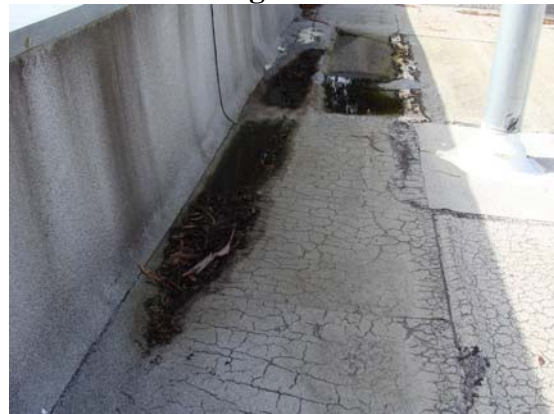
## **D. Serious failure of the membrane and the plywood roof sheathing at the rear wall.**

These photos show water ponding at the top of the slope ! This is of major concern as the rot is spreading into the 2x6 framing members and larger beams at the rear wall. (specifically at the rear of the fish store and the empty unit to the west)

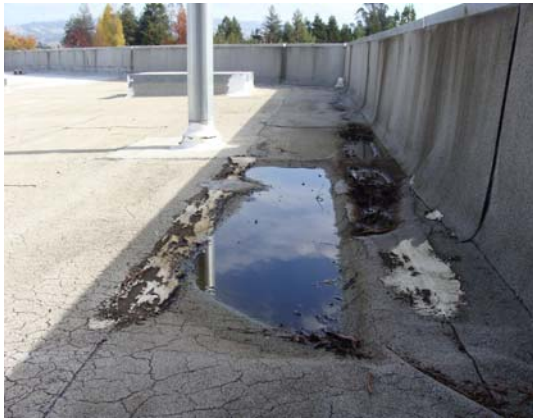
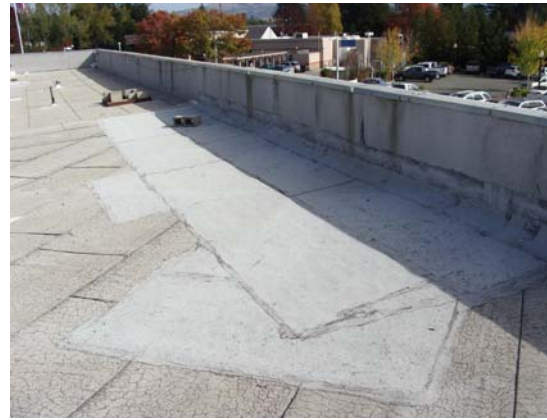
The photo on the left is above the fish store at the rear wall. This area will not support the weight of an adult person. It is very dangerous. The photo on the right is what appears to be repairs made to a similar situation more to the east of the fish store.

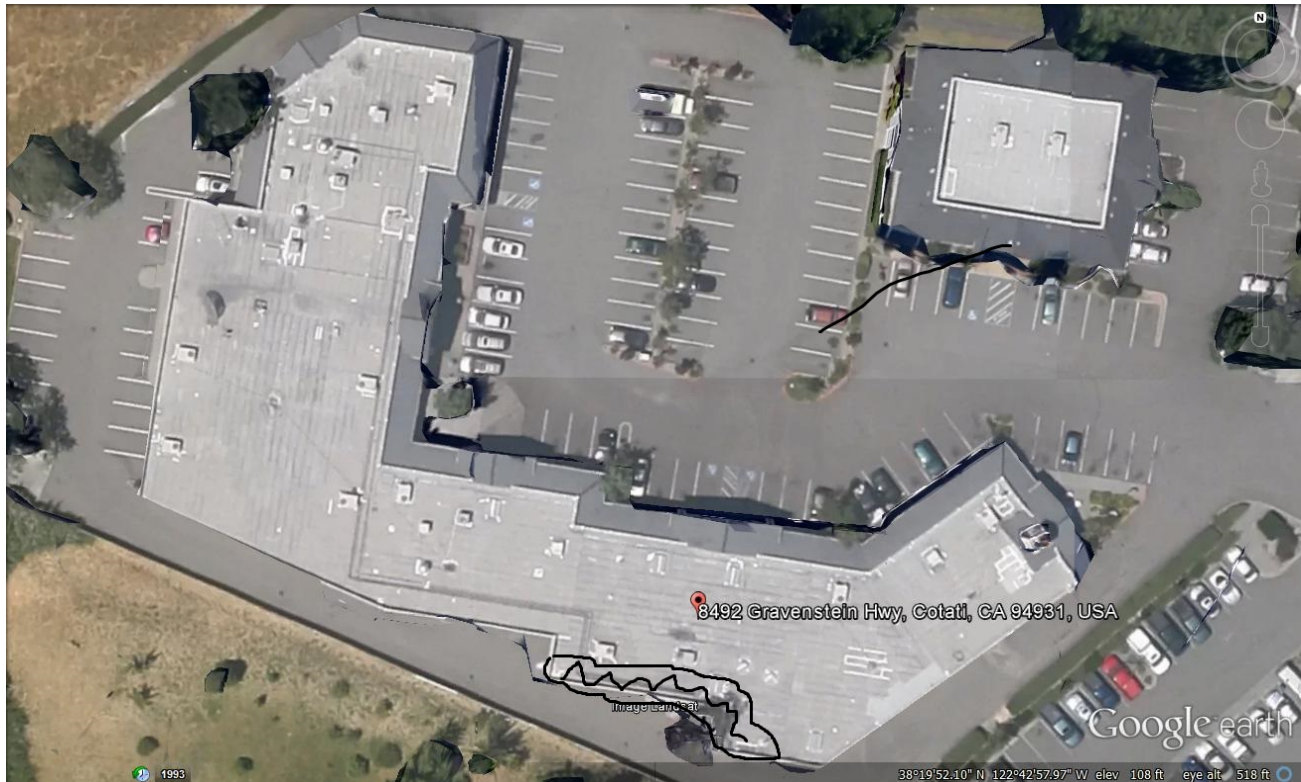
**This satellite shot shows the area of failure over the fish store marked in black scribbles.**

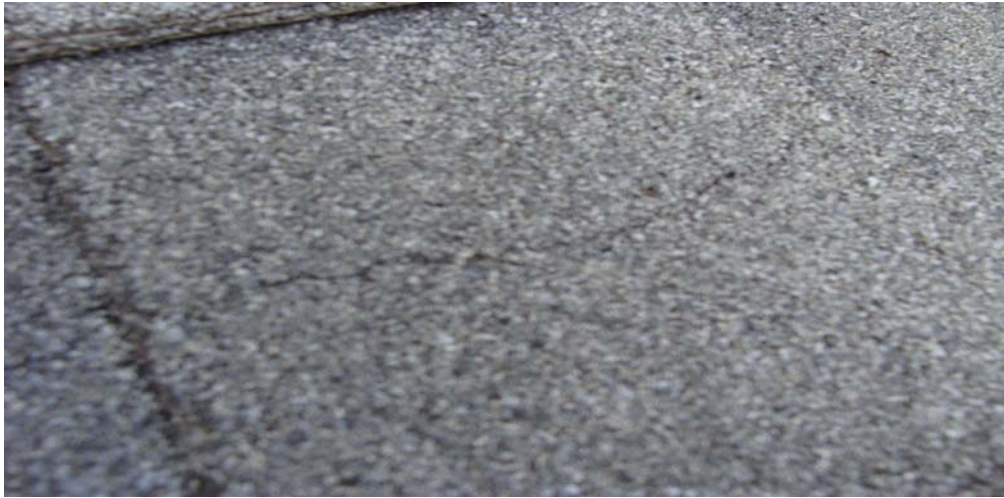
cracking of the composition shingle.

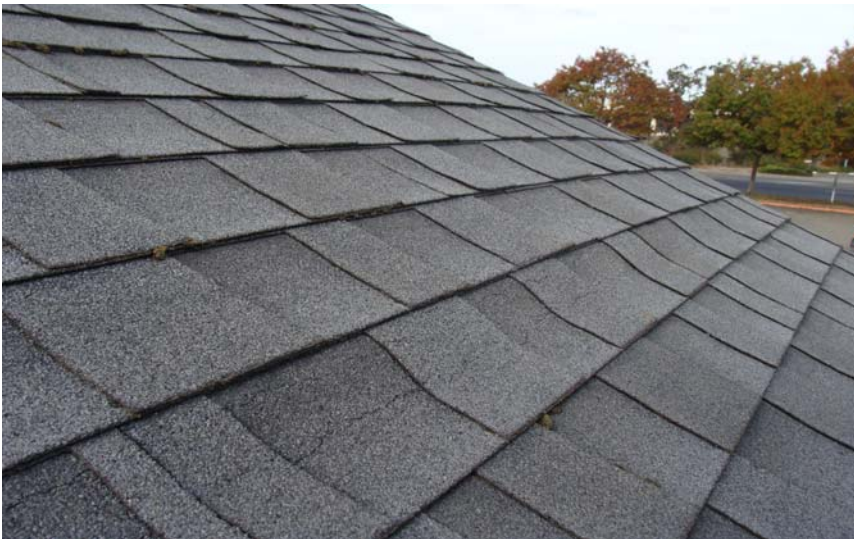
**More crack in the Composition shingle roof.**

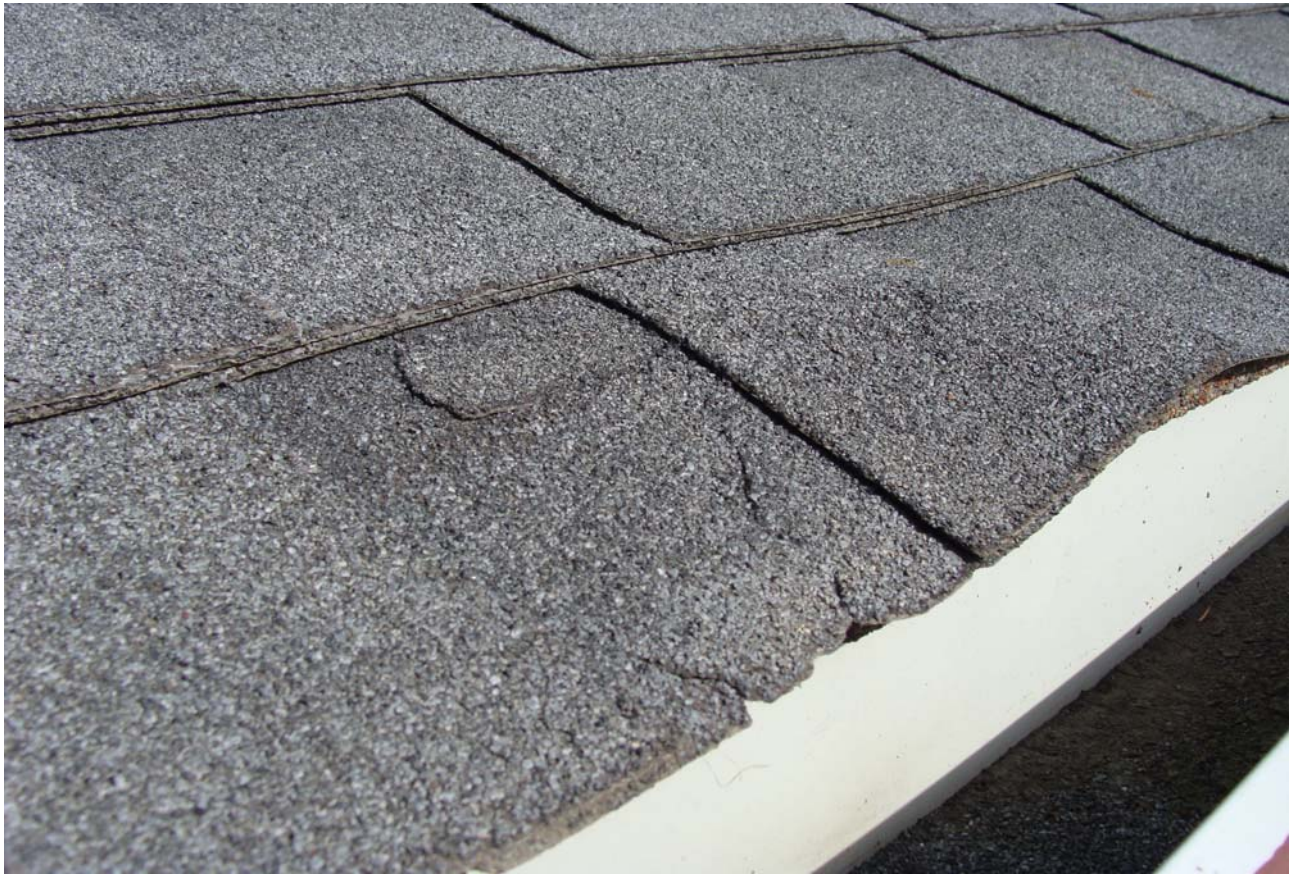
Several areas of the Composition Shingle roof show signs of buckling at the gutter. This is due to the starter shingle being improperly installed over 25 years ago.

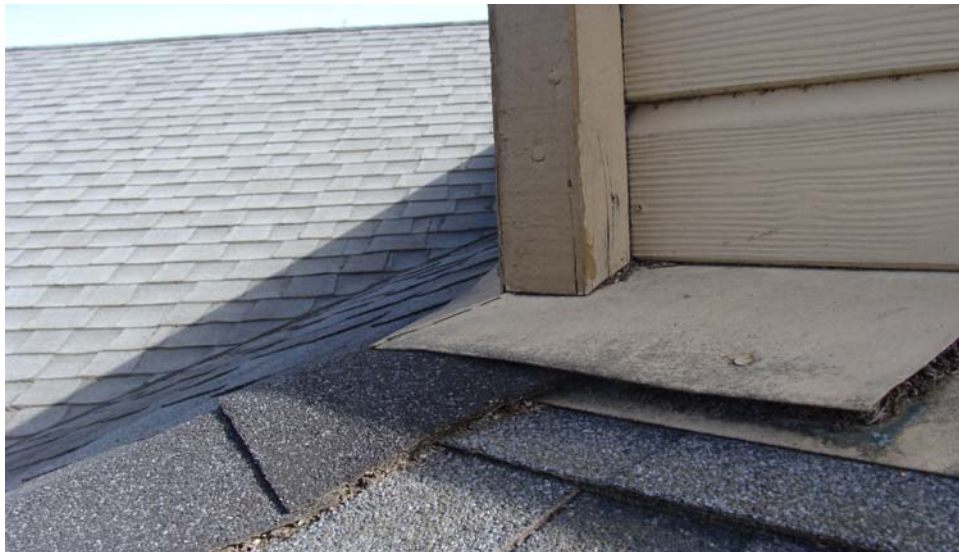
Loose fasteners at the roof to wall flashing.
