A Home Inspector's Journal: Decks and deck flashings

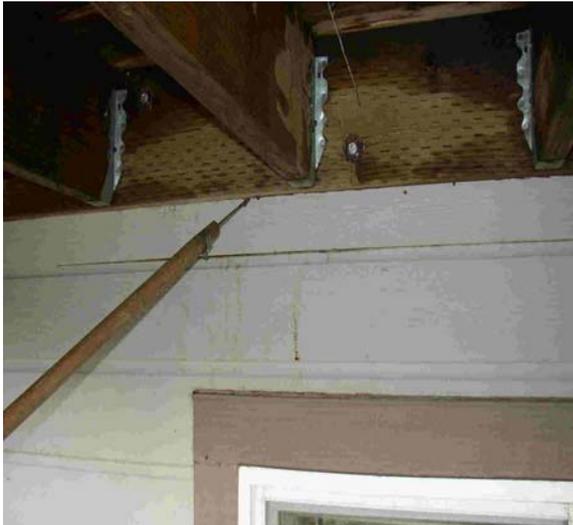
In the first picture, a wood deck has been attached directly to composite wood siding without the benefit of flashing. The attachment point, called a ledger board, is pressure treated and while visibly wet, is still intact. The composite wood siding did not fare as well and the probe easily penetrated the siding's surface even into the framing material of the wall. Water stains visible on the wall beneath the probe indicate that water had actually been leaking behind the siding and it was later determined the water was penetrating into the wall cavity itself. The damage in this case involved wall framing as well as

siding material and was estimated at over \$25,000.00.

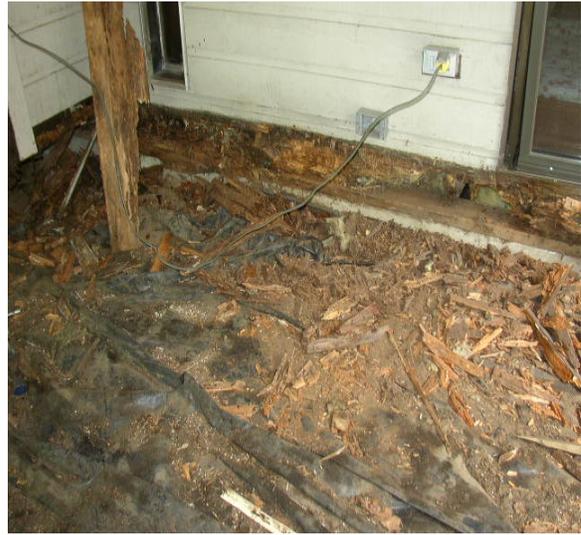
In the next picture the lack of flashing caused extensive damage to the structure including the siding, the rim joist and the ends of the floor joists. Moisture ants, which colonize decaying wood to feed on fungus, had been active throughout as were Dampwood Termites. The cost just to repair just the structure alone not including the deck was nearly \$3000.00
