## Home Inspector's Notes: Wood Boring Beetles Can Cause Serious Damage

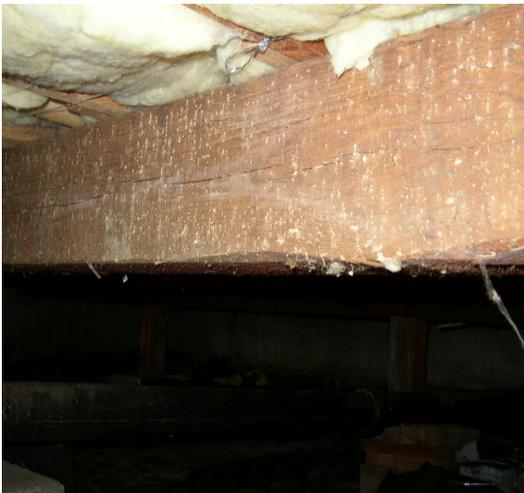
The first photo shows a beam in a sub-structure crawl space which is manifesting a very substantial infestation of deathwatch beetles. The beam is literally riddled with small bird-shot sized holes that have fine powdery wood sawdust or frass coming out of them. Seeing this frass in and beneath the small emergence holes indicates this is a very active infestation.

Because these beetles also require moisture to survive, it is important to make sure the sub-structure crawl space is adequately covered with plastic vapor barrier and that there is adequate crawl space ventilation. Foundation vents should never, ever be plugged or blocked. Lastly, in the case outlined here, a licensed applicator was called to provide chemical treatment.

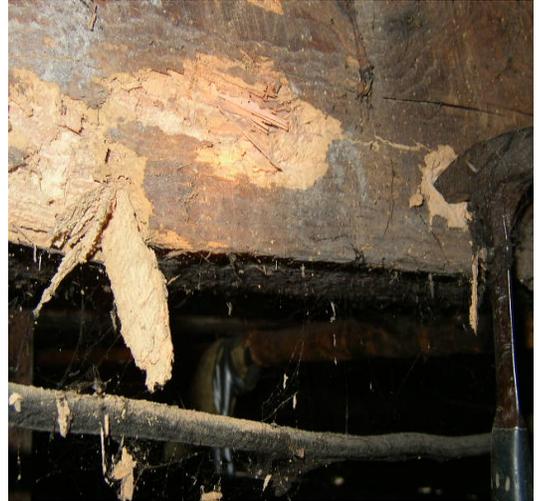
In the second photo, the damage is clear as the rock pick easily breaks through and stays imbedded in the beam. Much of the wood has been reduced to fine powder and the beam will need to be replaced. It is also important when performing repairs that if any damaged wood needs repaired, it should be removed completely. The practice of installing new wood adjacent to damaged wood (called crippling or sistering) is not a good practice when dealing with these types of beetles as they may then re-infest and damage the newly installed wood.
