PROPERTY CONDITION REPORT

Client(s): Sample Apartment Complex
Property: 1402 Washington St,
Calistoga, CA 94515
Realtor: Not Applicable
Date: December 12, 2015
Inspector: Rick DeBoard - Certification #1051
Report #: PCA7306

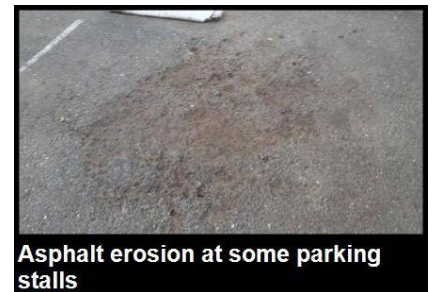
There are approximately 20 marked parking spaces for the subject property, none of which are marked for handicap only. Additional street parking is also available.

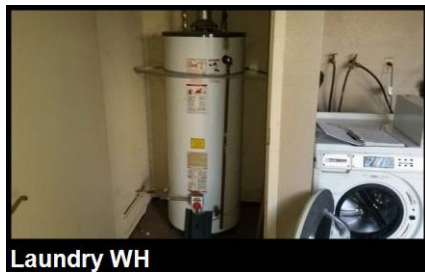
Laundry WH

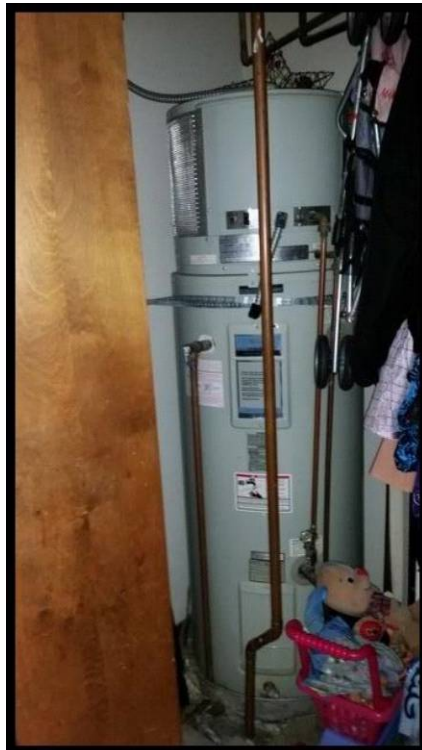
Typical of original apartment WH's

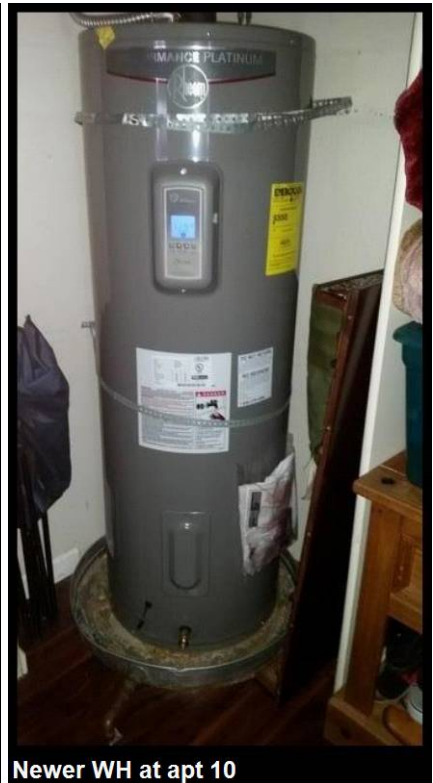
Newer WH at apt 10

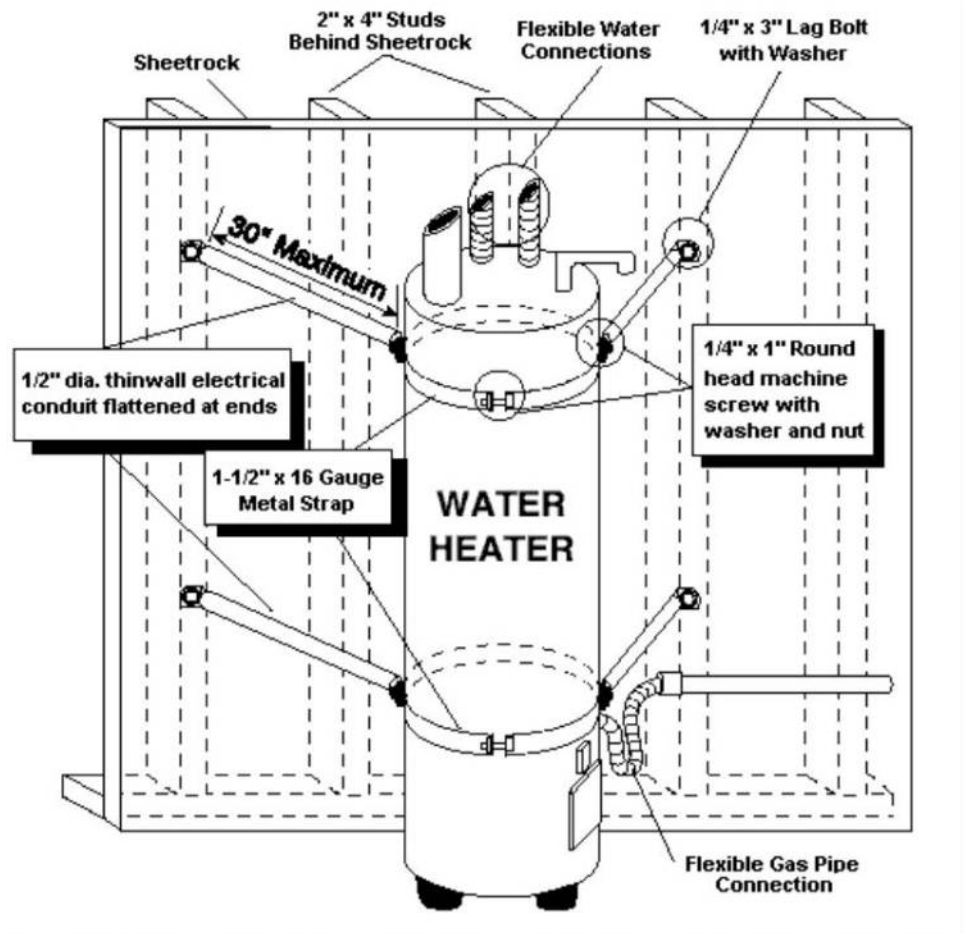
See the diagram for proper strapping requirements.

Several methods may be used to anchor or strap the water heater. One of the easier and less expensive methods is to **double** wrap the water heater top and bottom with metal strapping (also known as "plumbers tape", 16 gauge is recommended), and to attach the ends of the straps to wall studs with 1/4" X 3" lag screws with washers. No matter what method is used, it is important to use 1/4" X 3" lag screws into solid wood framing at each attachment. This law applies state wide except where superseded by local codes.

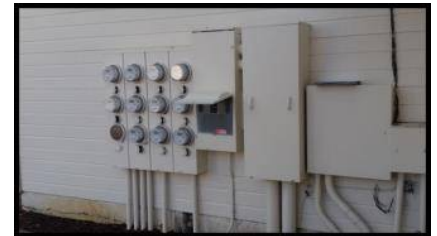
10.2 Service Disconnect

The main disconnects are located at the north exterior wall of building A. The rating of the service disconnect equipment is unknown, it is not labeled. Overload protection is provided by breakers. Good condition. 120/240 volts. 1Phase, 3Wire.

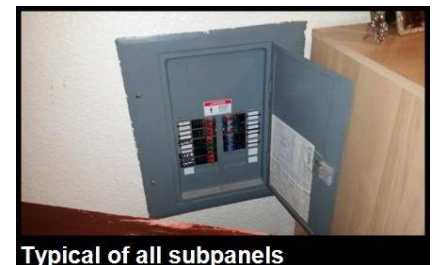
10.3 SubPanels

Located at each of the apartment hallways, also one in the laundry room (this is the "house" panel). All are manufactured by Challenger. 120/240 volts. All subpanels are rated at 100 to 125 amps. 1Phase, 3Wire. No apparent hazards were noted at any of the subpanels.
