## PROPERTY CONDITION REPORT

**Client(s):** Mr. George Sample  
**Property:** 8492 CA-116,  
Cotati, CA 94931  
**Realtor:** Not Applicable  
**Date:** Tuesday, November 18, 2014  
**Inspector:** Rick DeBoard - Certification #1051  
**Report #:** PCA7185

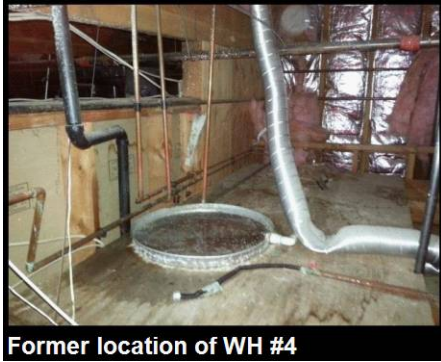
Former location of WH #4

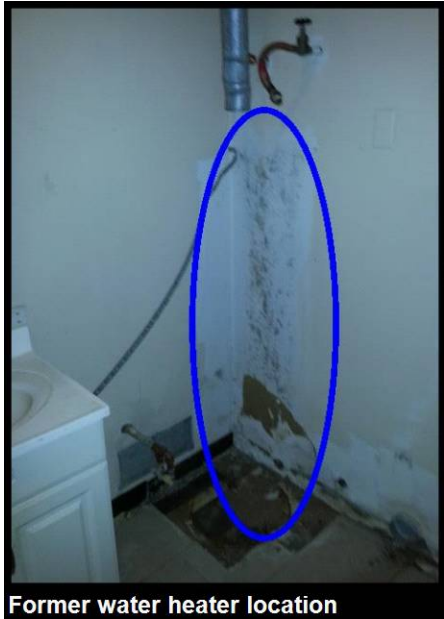
Former water heater location

The walls are damaged and in need of repair at the east wall of suite F, apparently from a former leaking water heater in the attic.

Organic growth type substance was noted at the base of this wall, see the recommendations regarding a MOLD inspection in the EXECUTIVE SUMMARY section of this report.

It is a minor cost item to repair the wall (after the potential mold has been resolved)

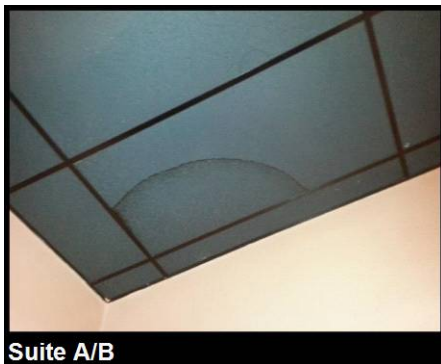
Suite A/B

Moisture stains were noted at almost every suite. These stains APPEAR to be the result of past, rather than current roof leakage. However it is not possible to be absolutely certain.

This is a minor cost item to replace ceiling tile, see roofing section for costs associated with repairing roof.

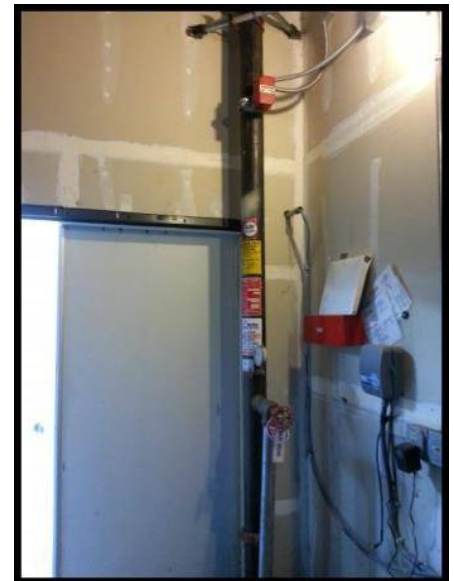
The main riser for the sprinkler system is located at the electrical room.

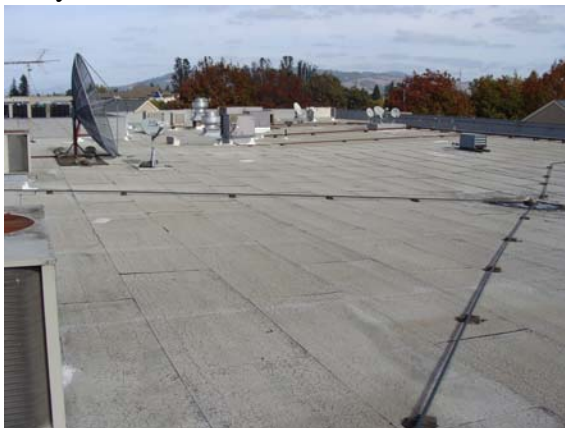
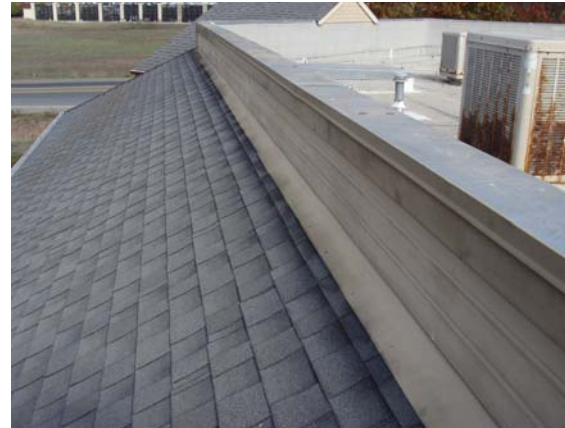
**GENERAL CONDITION:** Existing roof includes:

- **A low slope built up asphalt roof system, a steep slope composition shingle system and eave gutters.** The low slope system appears to be a mechanically fastened base sheet with a mid ply of fiberglass ply sheet and a modified asphalt cap sheet with a mineral surface.

The steep slope system is a laminated fiberglass and asphalt composition shingle, over an asphalt saturated underlayment sheet.

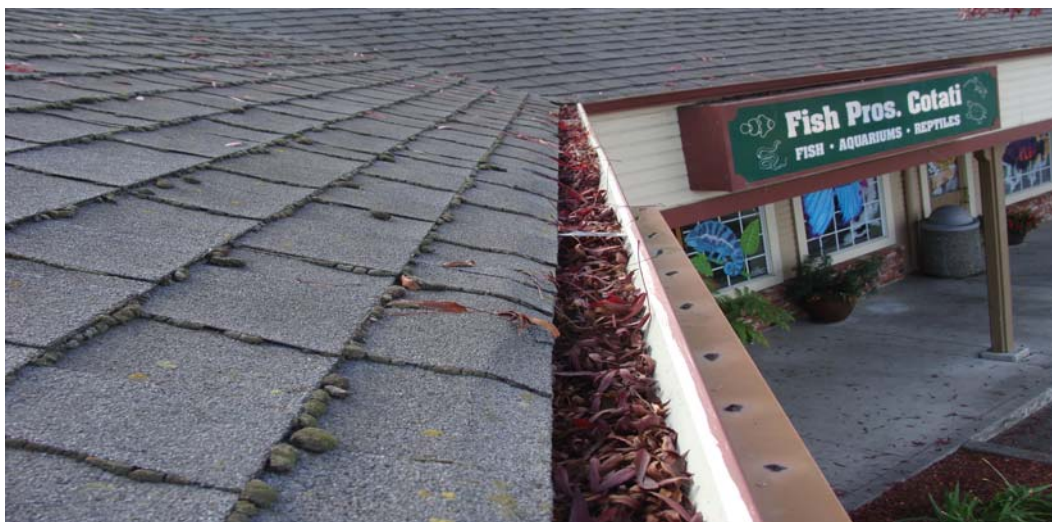
Several areas of the Composition Shingle roof show signs of buckling at the gutter. This is due to the starter shingle being improperly installed over 25 years ago.

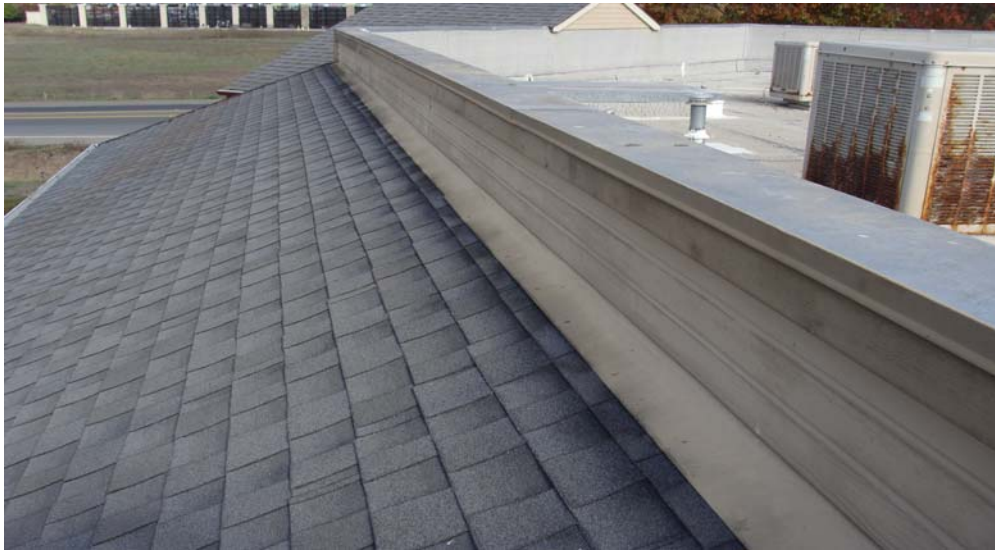
The gutters appear to be in good condition and some minor cleaning required.
