HAWAIIAN VILLAGE
CONDOMINIUM ASSOCIATION

REPLACEMENT RESERVE STUDY
2007

RE: HAWAIIAN VILLAGE CONDOMINIUM ASSOCIATION – WAI-KI-KI
Replacement Reserve Report

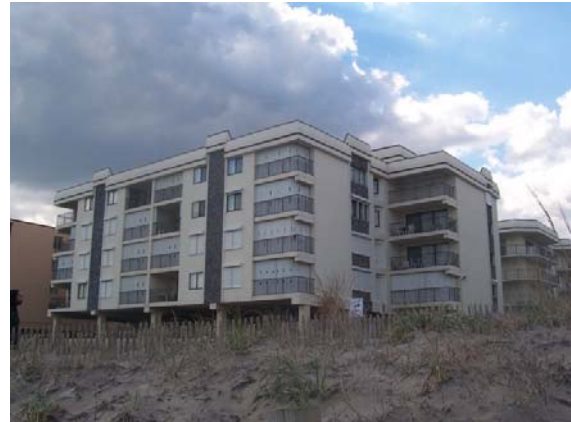
Photo 1 - Beach side elevation

The subject property appears to be in good overall condition for its age. The general upkeep of the common facilities reflects the conscientiousness of the building manager and staff. This report is based on normal life expectancy of the building components and does not include repair costs related to storm damage. The following comments pertain to the larger, more significant components in the property's inventory and to those items that are unique or deserving of attention because of their condition or the manner in which they have been treated in the analysis.

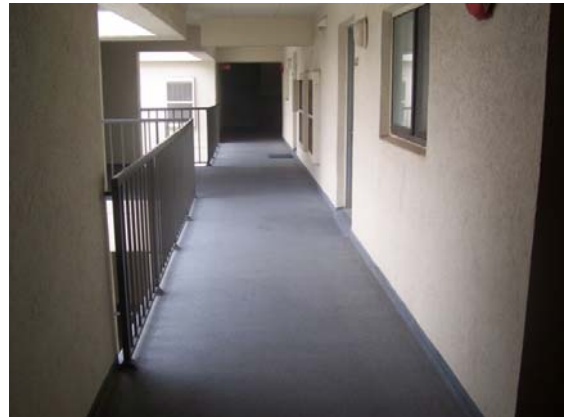
Photo 2 – Exterior walkway coated

Concrete Walkway and Stairs. The concrete stairs are showing signs of spalling. As this re-bar rusts it will increase the speed in which the stairs will fail. The areas of exposed re-bar need to be sealed. The walkway has been recently resurfaced and is in good condition.

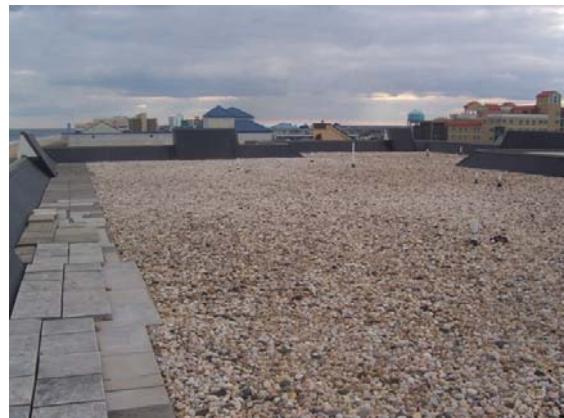
Photo 3 - Single ply roofing system - ballasted

Roofing. The roof is covered with a single membrane with a ballasted covering. The roofing system was replaced in 2006 and is in very good condition. The roof has been properly ballasted with a double layer of concrete walking pads along the roof edge.

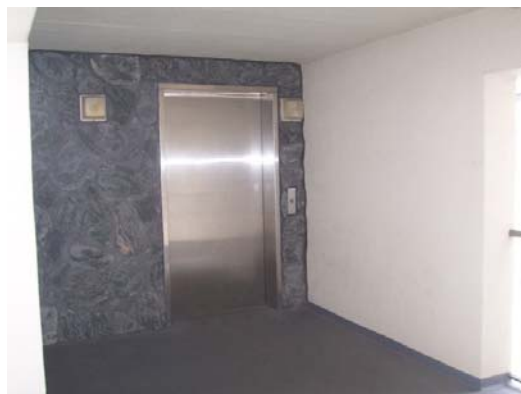
Photo 5 - Elevator

Elevators. The estimated cost of replacing the major components of the building elevators has been developed utilizing R.S. Means Construction Cost Data. These costs are included to reflect the obsolescence that occurs with elevator systems. Even though the systems may be functioning well at this time, parts for most mechanical control systems are becoming increasingly hard to find. Parts availability becomes a major consideration that forces a replacement decision. When this work is ultimately accomplished, the elevators will have to be brought into compliance with the latest safety code requirements. This work typically entails upgrading door operating mechanisms, replacing elevator call systems and installation of emergency phones. A prudent amount has been included in anticipation of these problems.

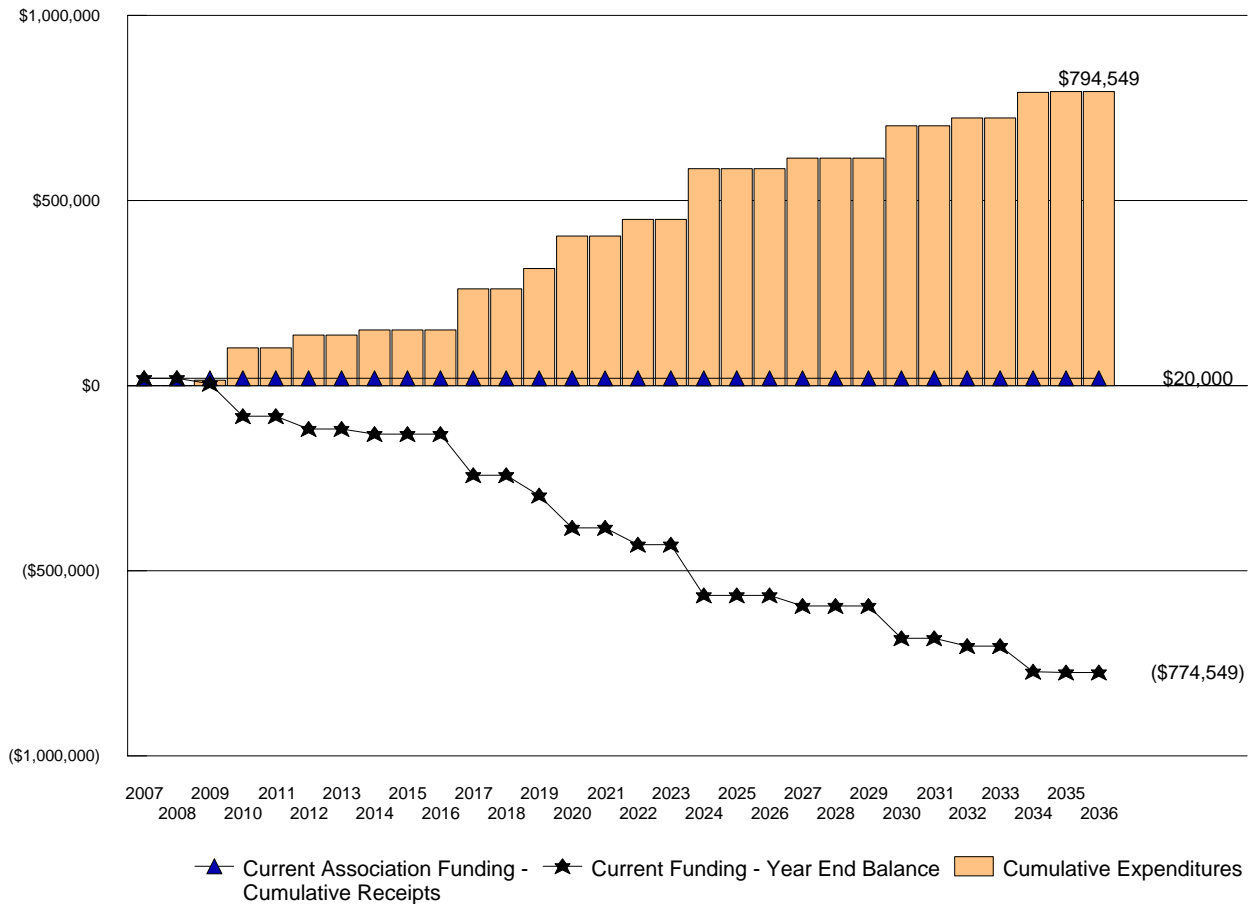
Current Association Funding - Cumulative Receipts and Expenditures Graph

Current Funding: This reserve study has been prepared for Fiscal Year 2007. The *Replacement Reserves Reported to be on Deposit* at the start of the year are reported to be \$20,000. The information concerning this balance has been supplied by the Association's representative, and confirmation or audit of the balance is beyond the scope of the study. The planned annual contribution to reserves for the Fiscal Year is \$0, which is equivalent to an average contribution of \$0 per unit per month. Based on currently projected expenditures, the Homeowners' Association will deplete the reserve fund in the year 2010 and will incur a deficit of \$82,190 in that year if annual reserve contributions are not increased. See Page A-5 for details.
