## Inspector Secrets - Pabco HO-25 Roofing

Pabco HO-25 roofing material, short for, Horizon 25, was a 25 year warranted three tab, laminated shingle developed by Pabco in Tacoma. It was used widely in many areas until it was discontinued in 1996.

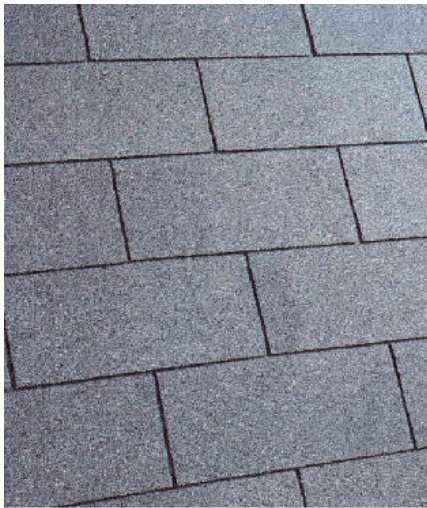
On the left, a typical 3 Tab Shingle

On the right, HO-25. Note the shadow lines and dimensional appearance as well as the cracking.
