# Encore Cabinets

The old ones had the wrong look, they were in the wrong place, and they were too good to toss

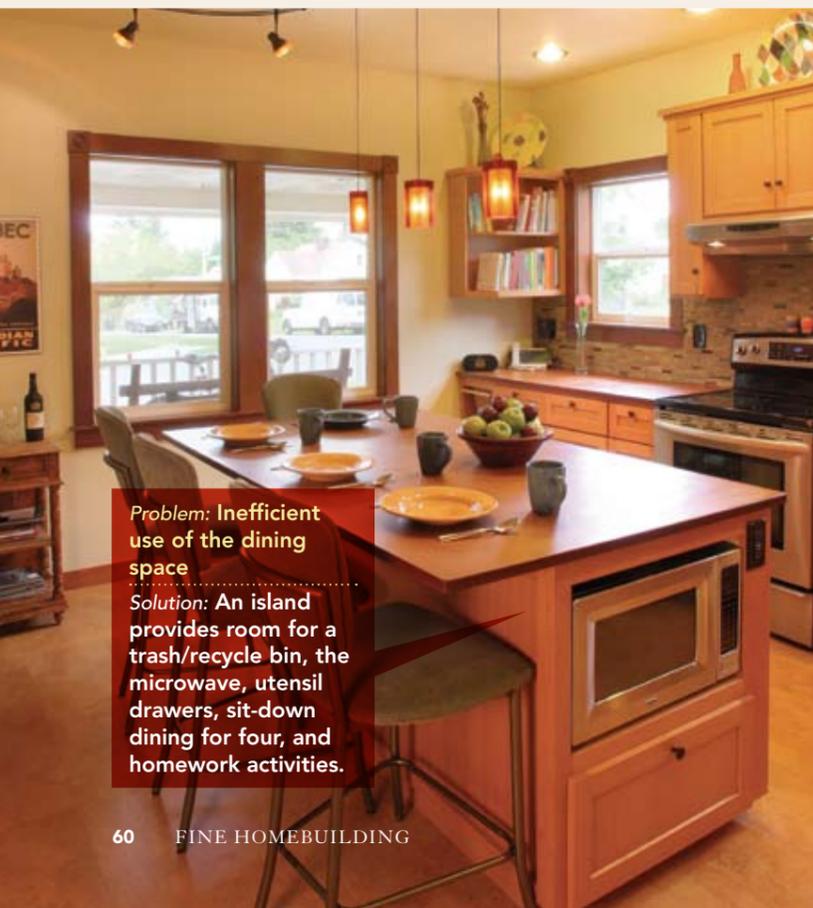
**Problem:** Inefficient use of the dining space

**Solution:** An island provides room for a trash/recycle bin, the microwave, utensil drawers, sit-down dining for four, and homework activities.

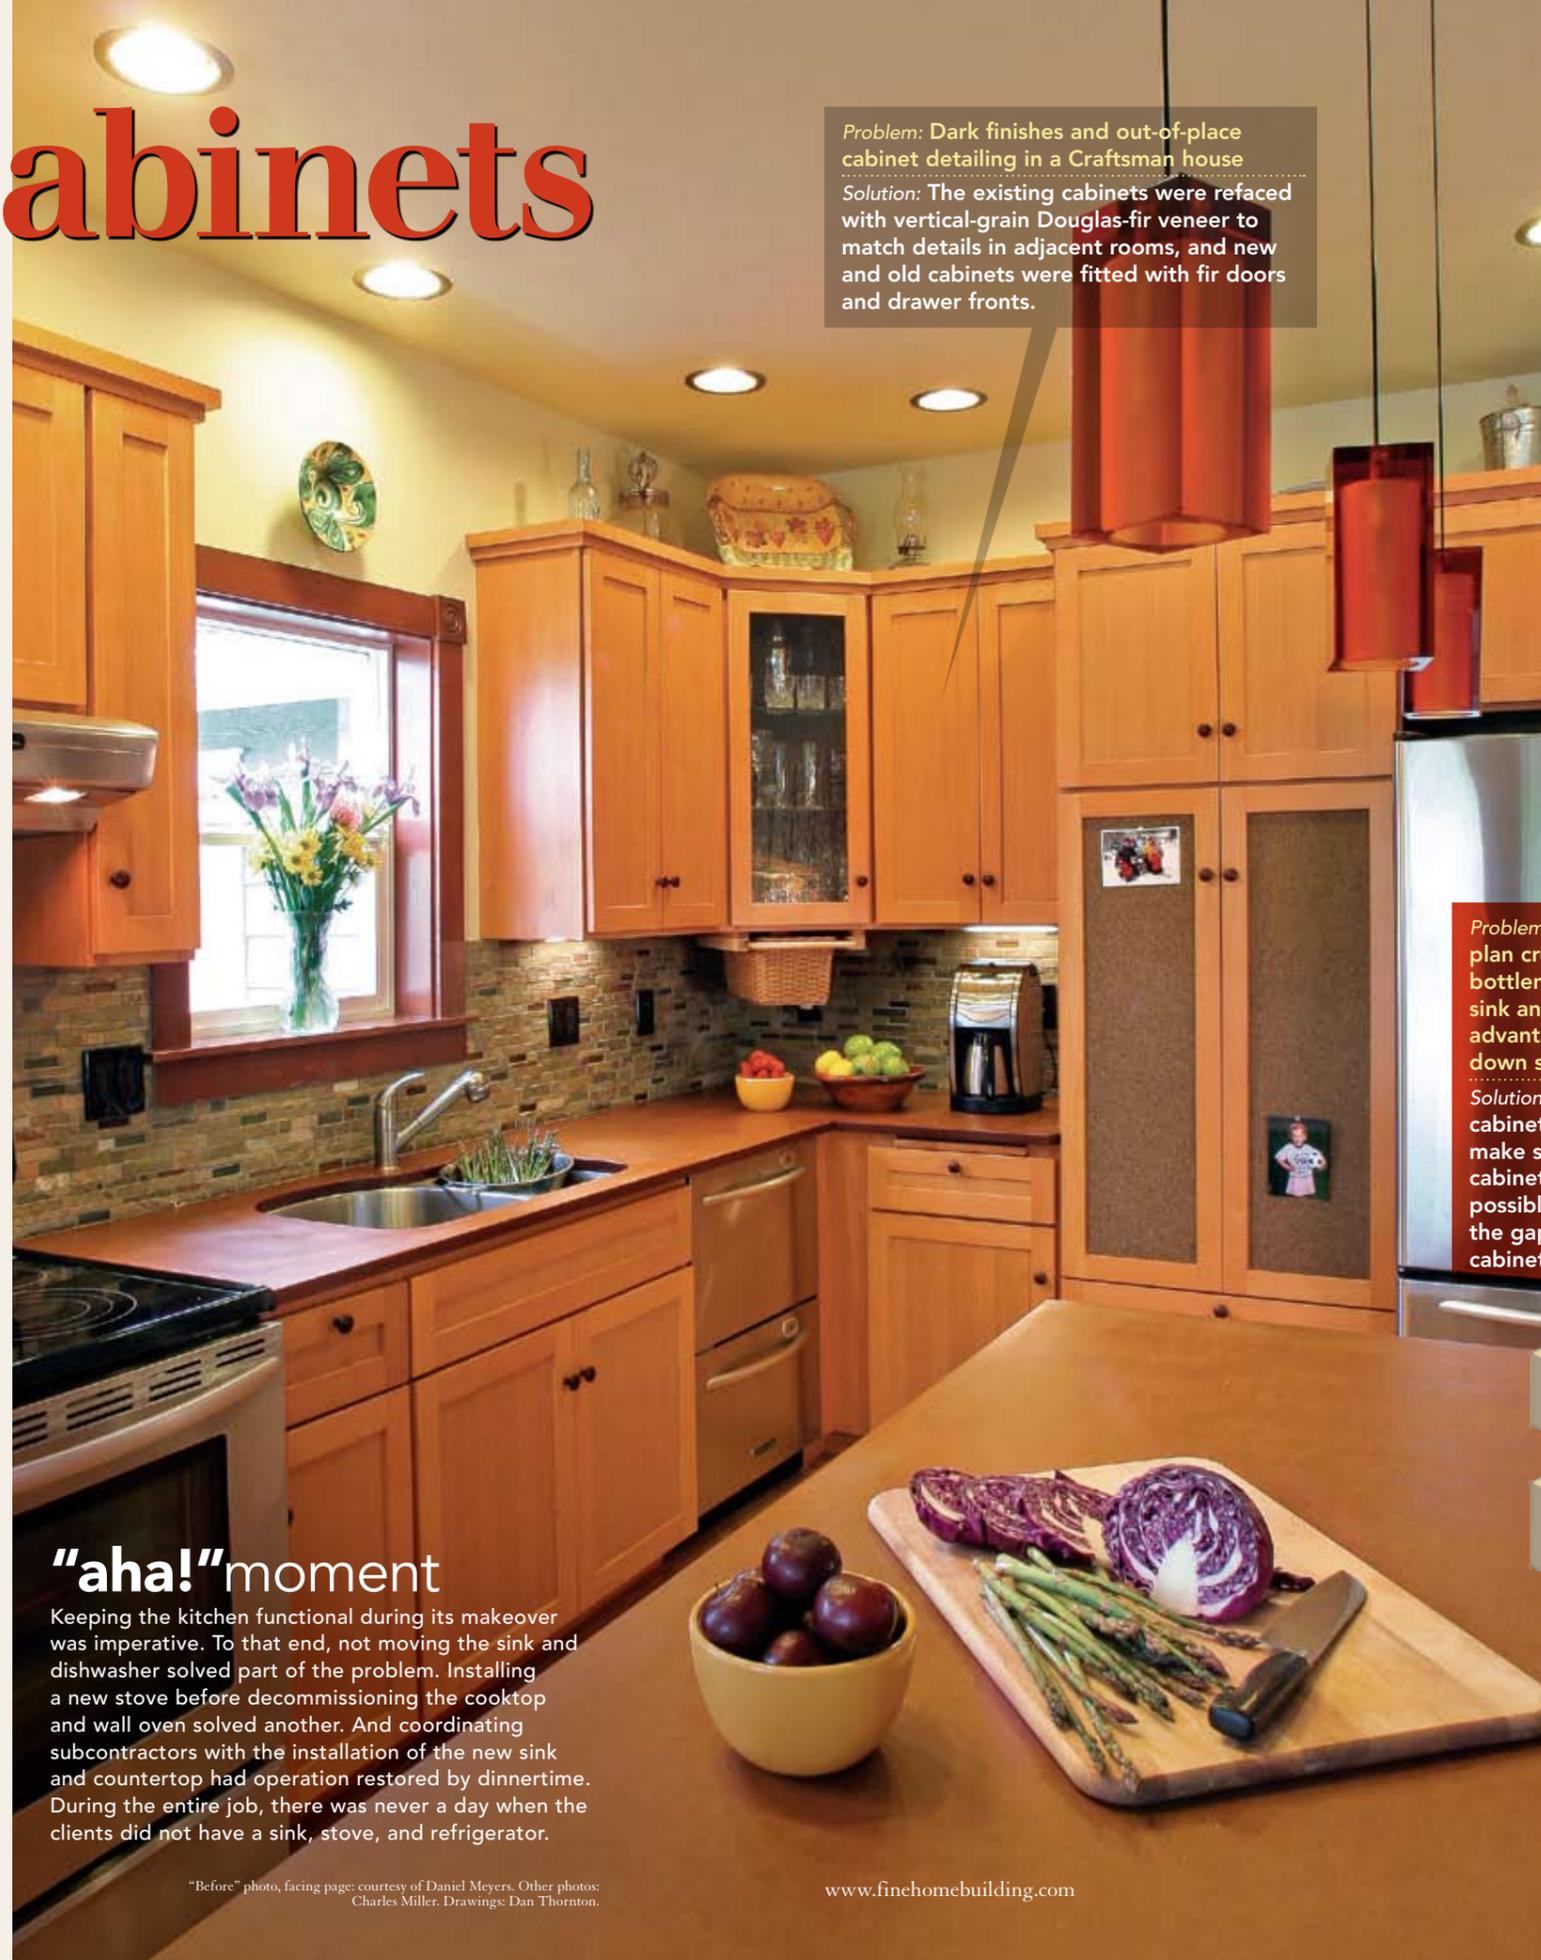
**Problem:** Dark finishes and out-of-place cabinet detailing in a Craftsman house  
**Solution:** The existing cabinets were refaced with vertical-grain Douglas-fir veneer to match details in adjacent rooms, and new and old cabinets were fitted with fir doors and drawer fronts.

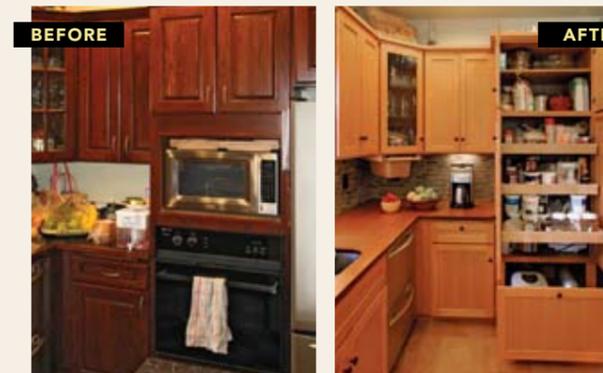
## Cool detail

The old wall-oven cabinet has been refitted with sliding shelves and a big drawer to serve as a pantry and small-appliance storage. The lower doors have cork message-board panels.

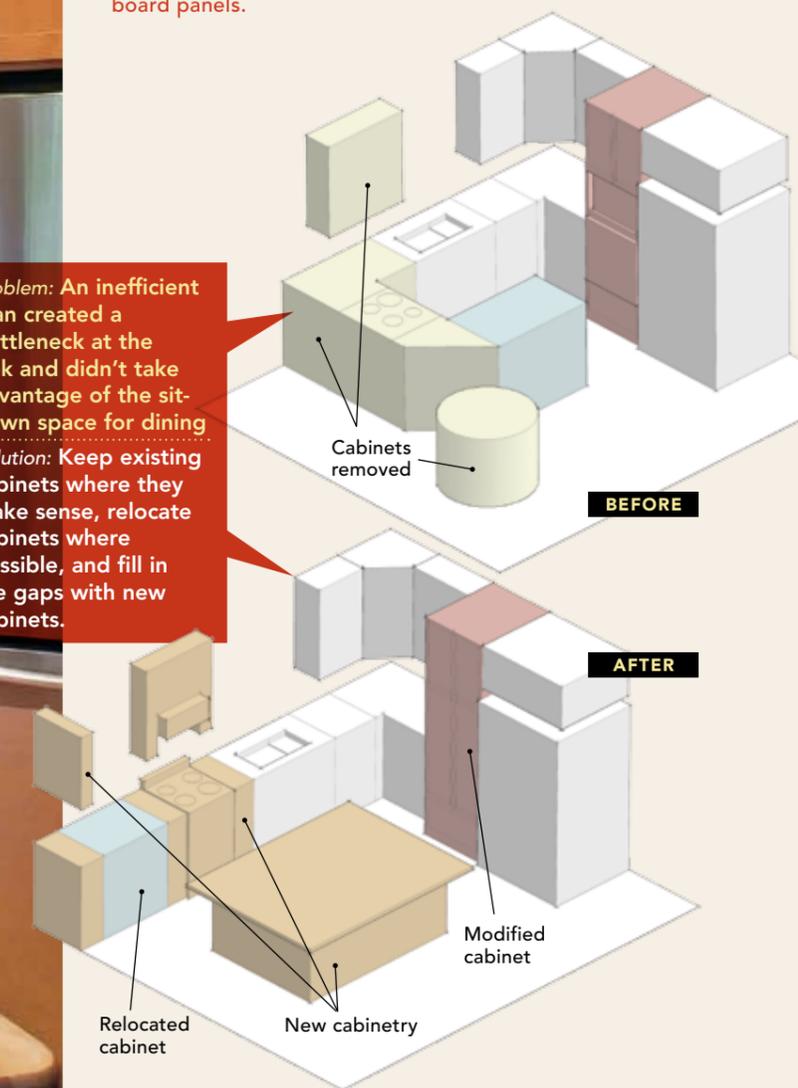
**Problem:** An inefficient plan created a bottleneck at the sink and didn't take advantage of the sit-down space for dining  
**Solution:** Keep existing cabinets where they make sense, relocate cabinets where possible, and fill in the gaps with new cabinets.
